# Rocglen Coal Mine Community Consultative Committee Meeting #10

## Environmental Monitoring Report October – December 2010

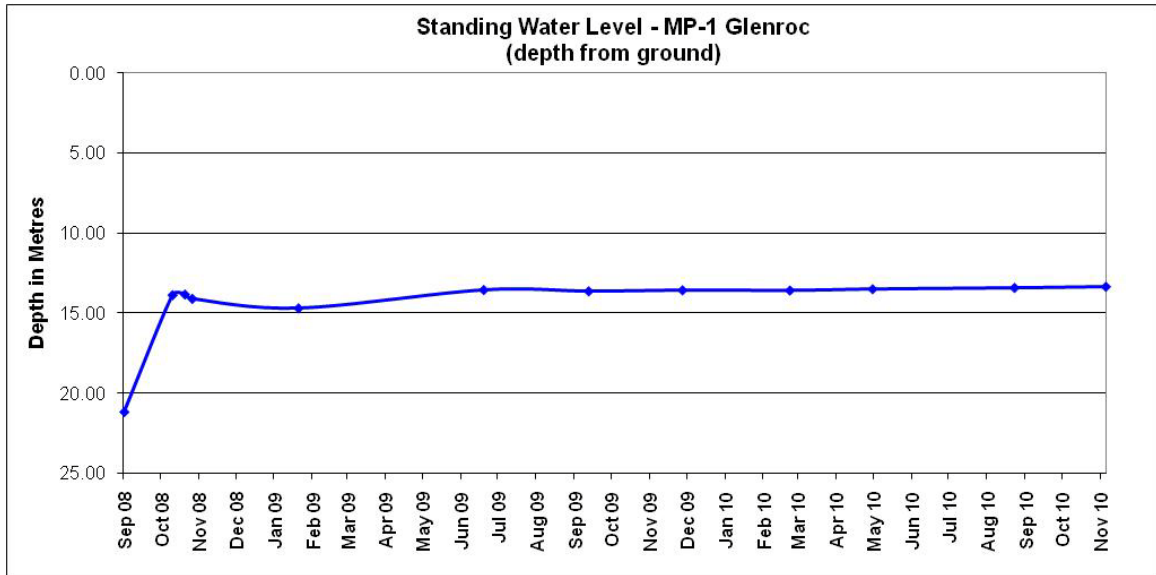
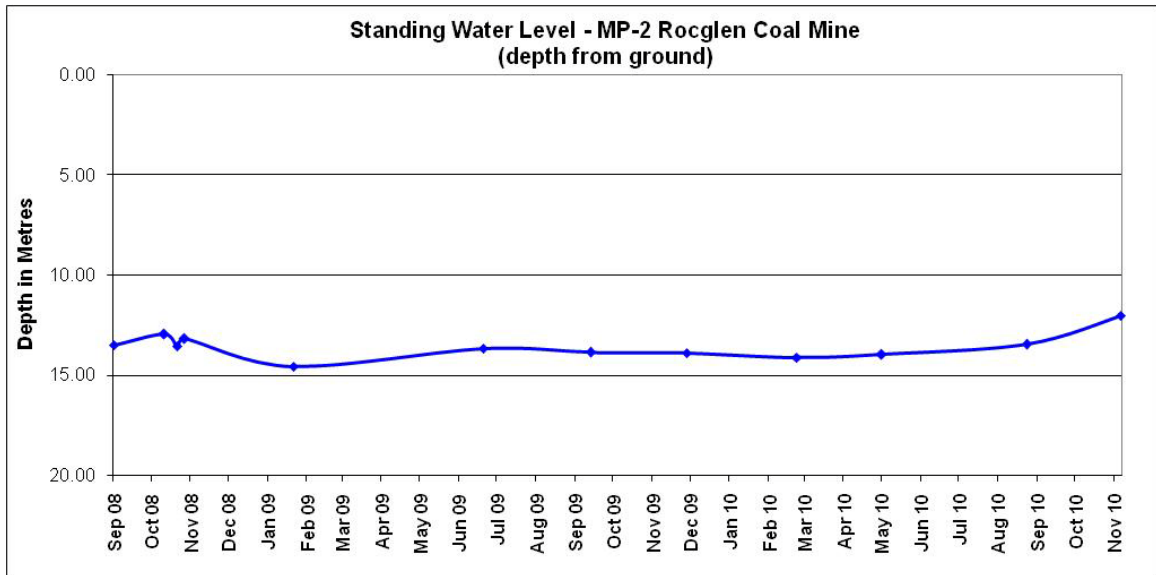
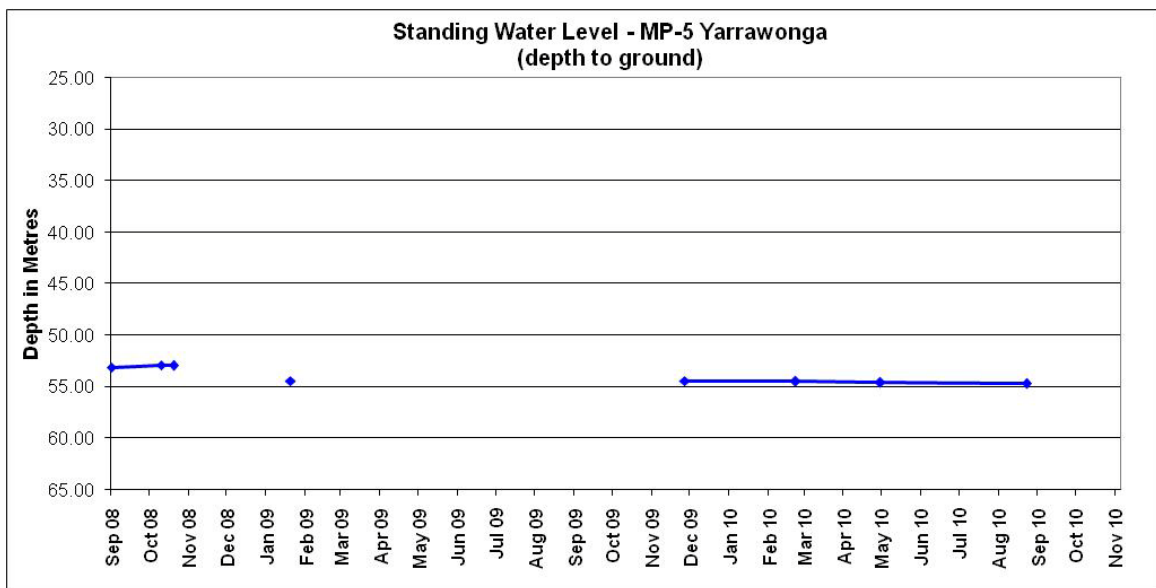
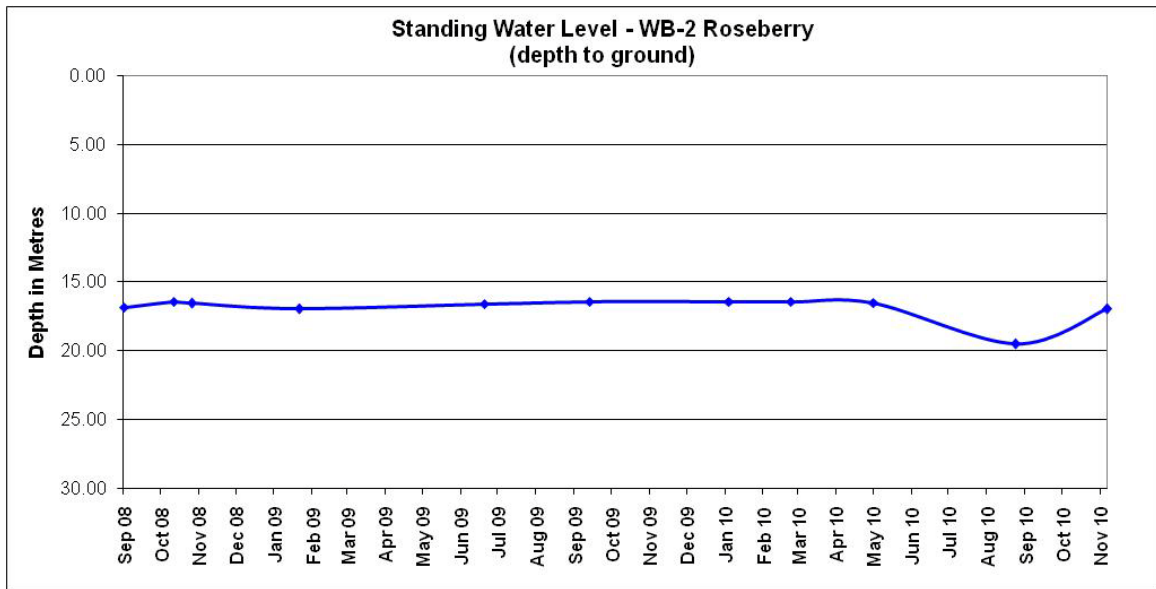
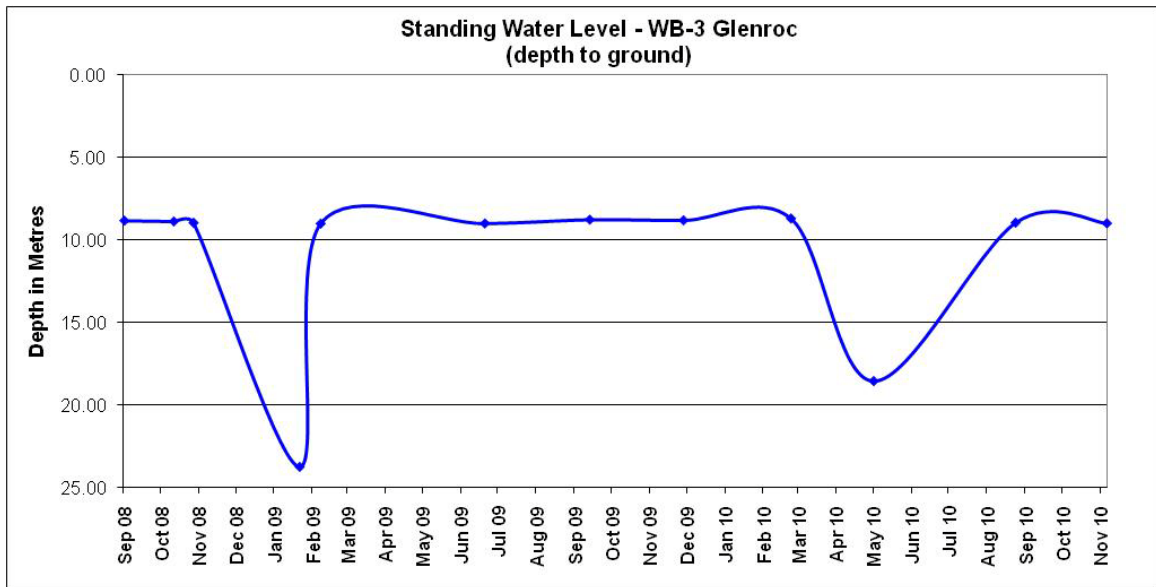
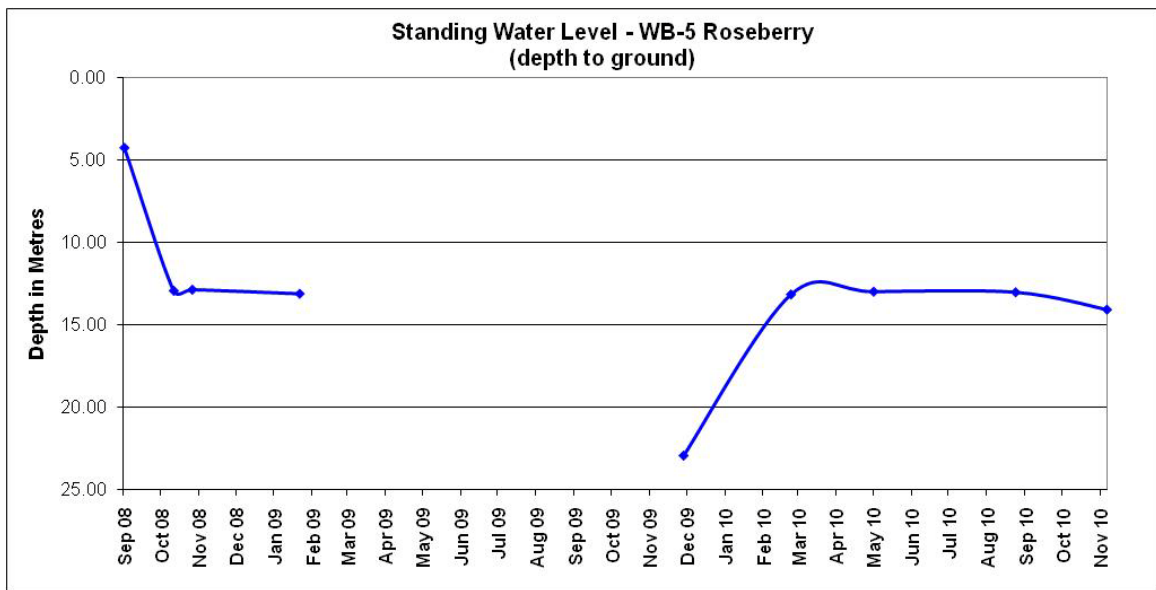
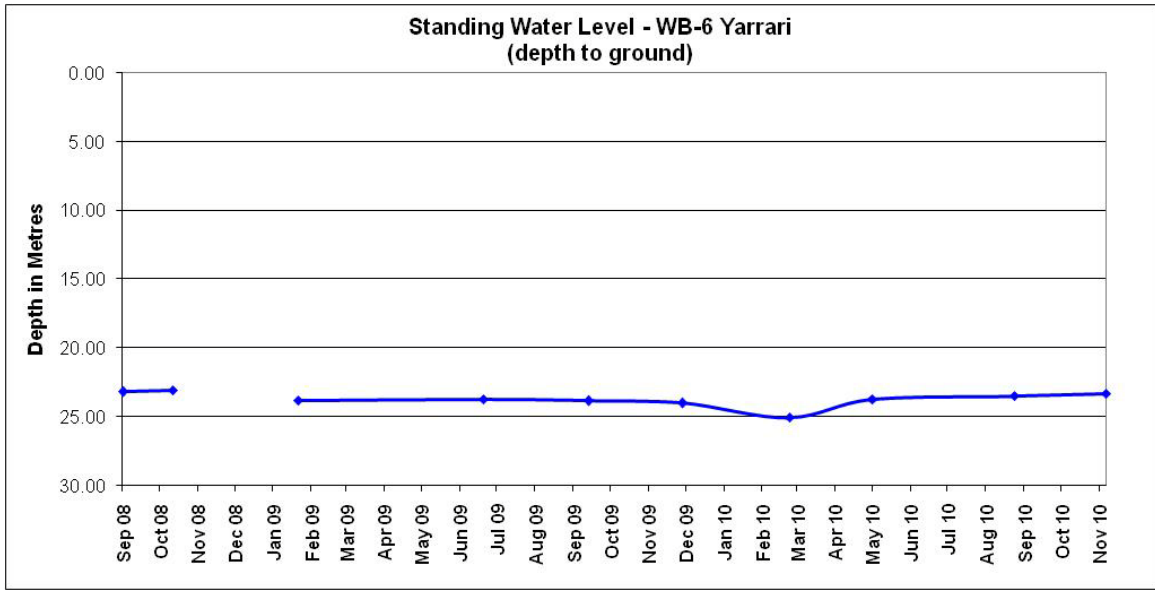
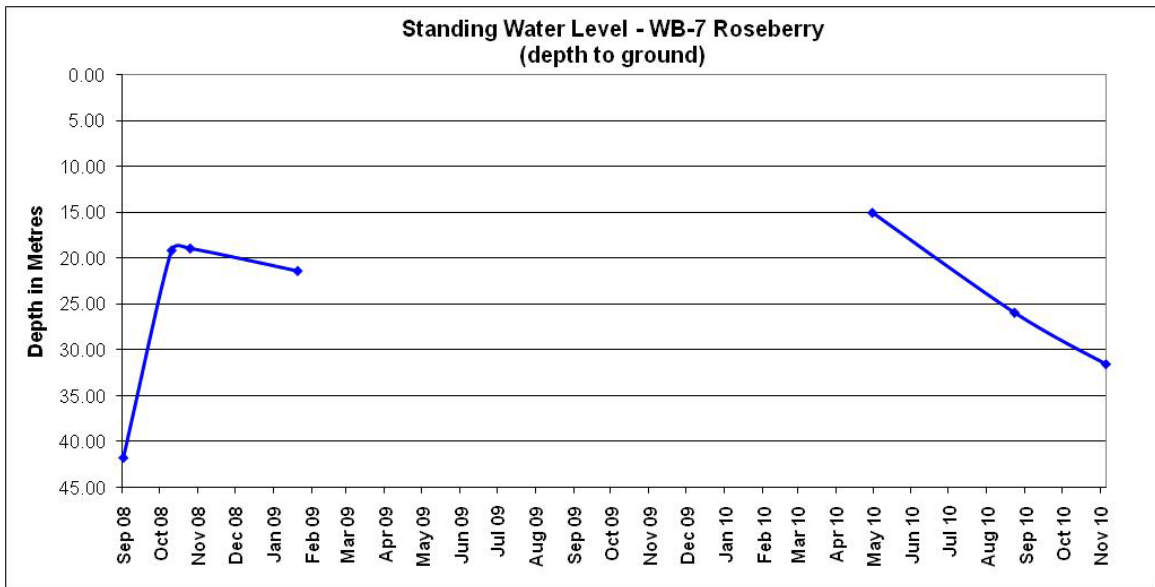
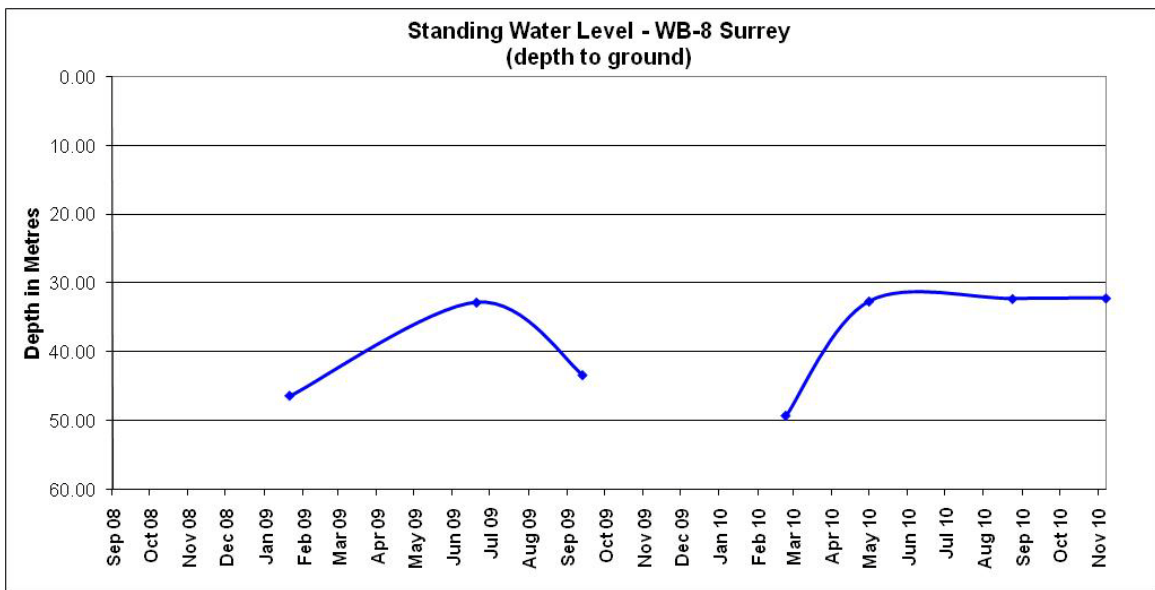
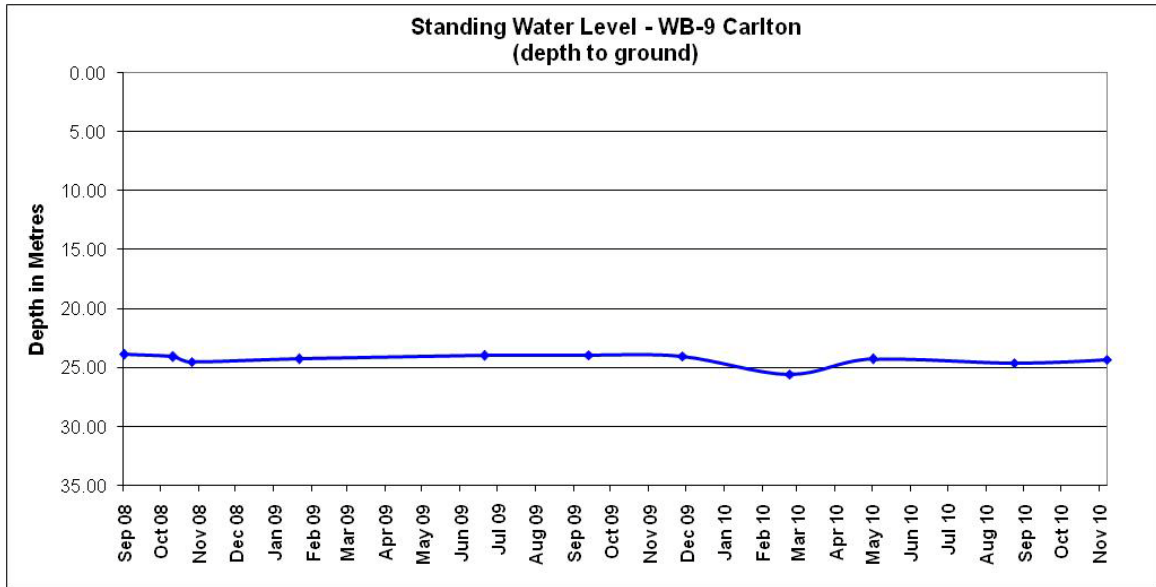
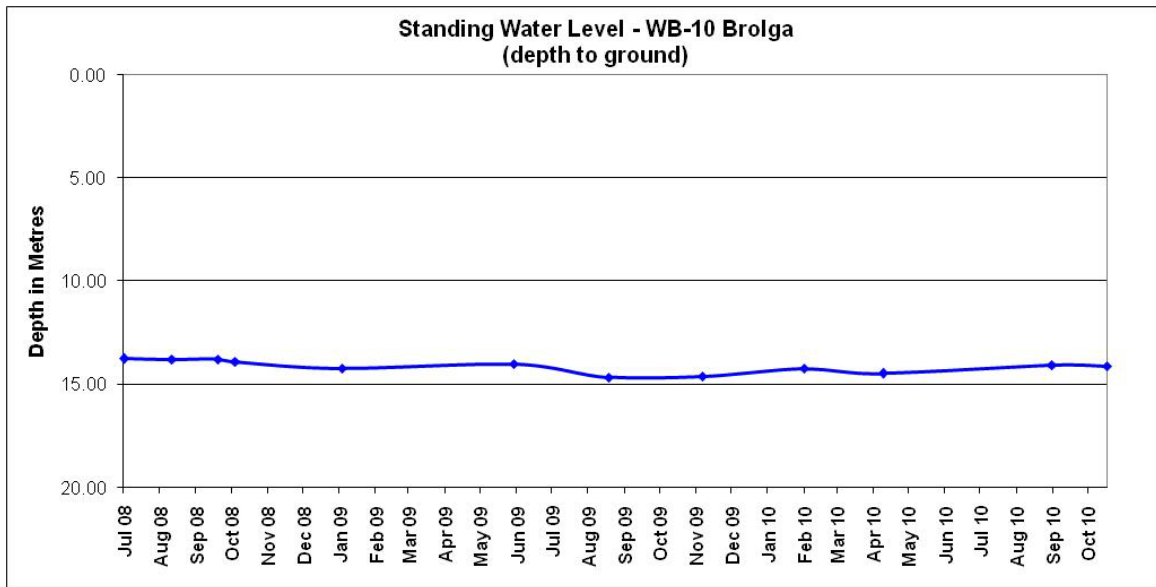
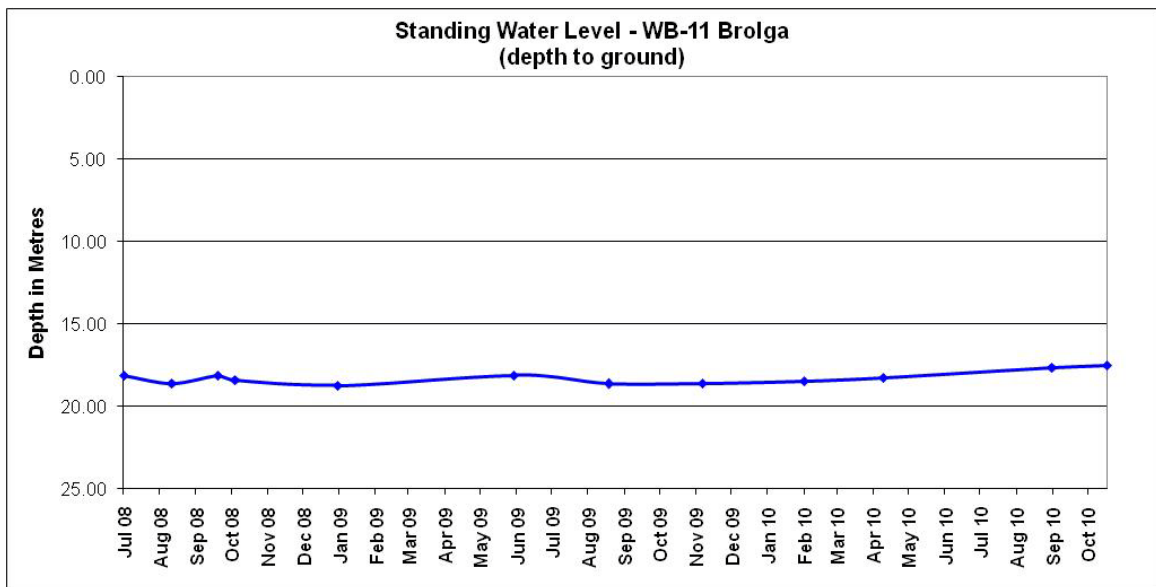
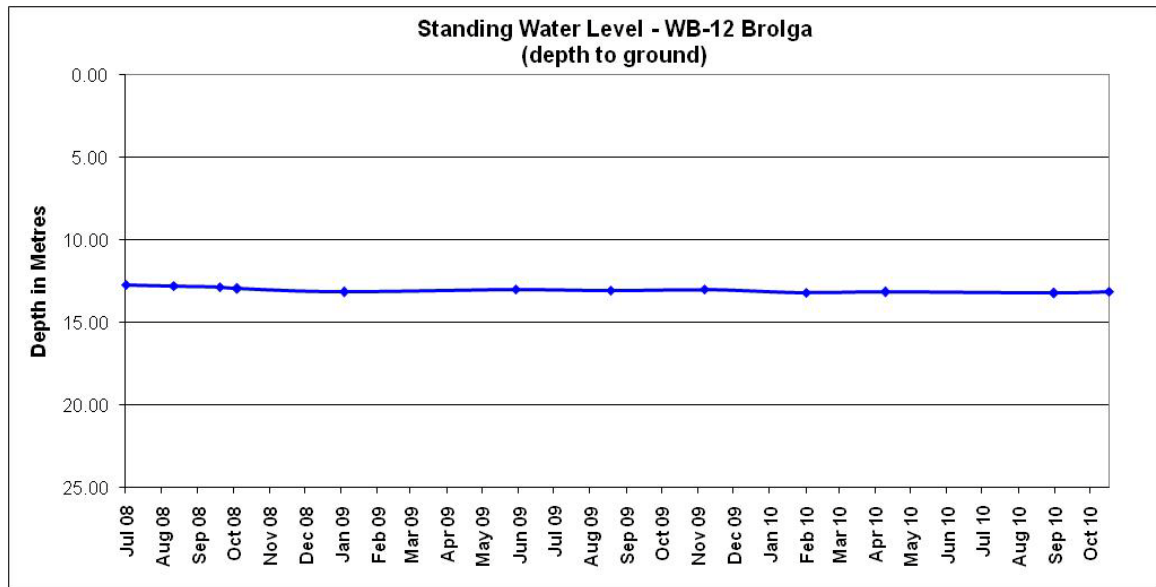
Standing water levels have remained relatively consistent since the last CCC meeting with the exception of WB7, which has continued to drop since May 2010, dropping approximately 5.62m over the last 3 months. Routine monitoring at this bore has indicated fluctuating water levels that are most likely associated with the connected windmill actively drawing water during monitoring events. The next round of monitoring in February 2011 will continue to observe any ongoing trends.
