Werris Creek Coal Mine

**Community
Consultative
Committee**

13 October 2005

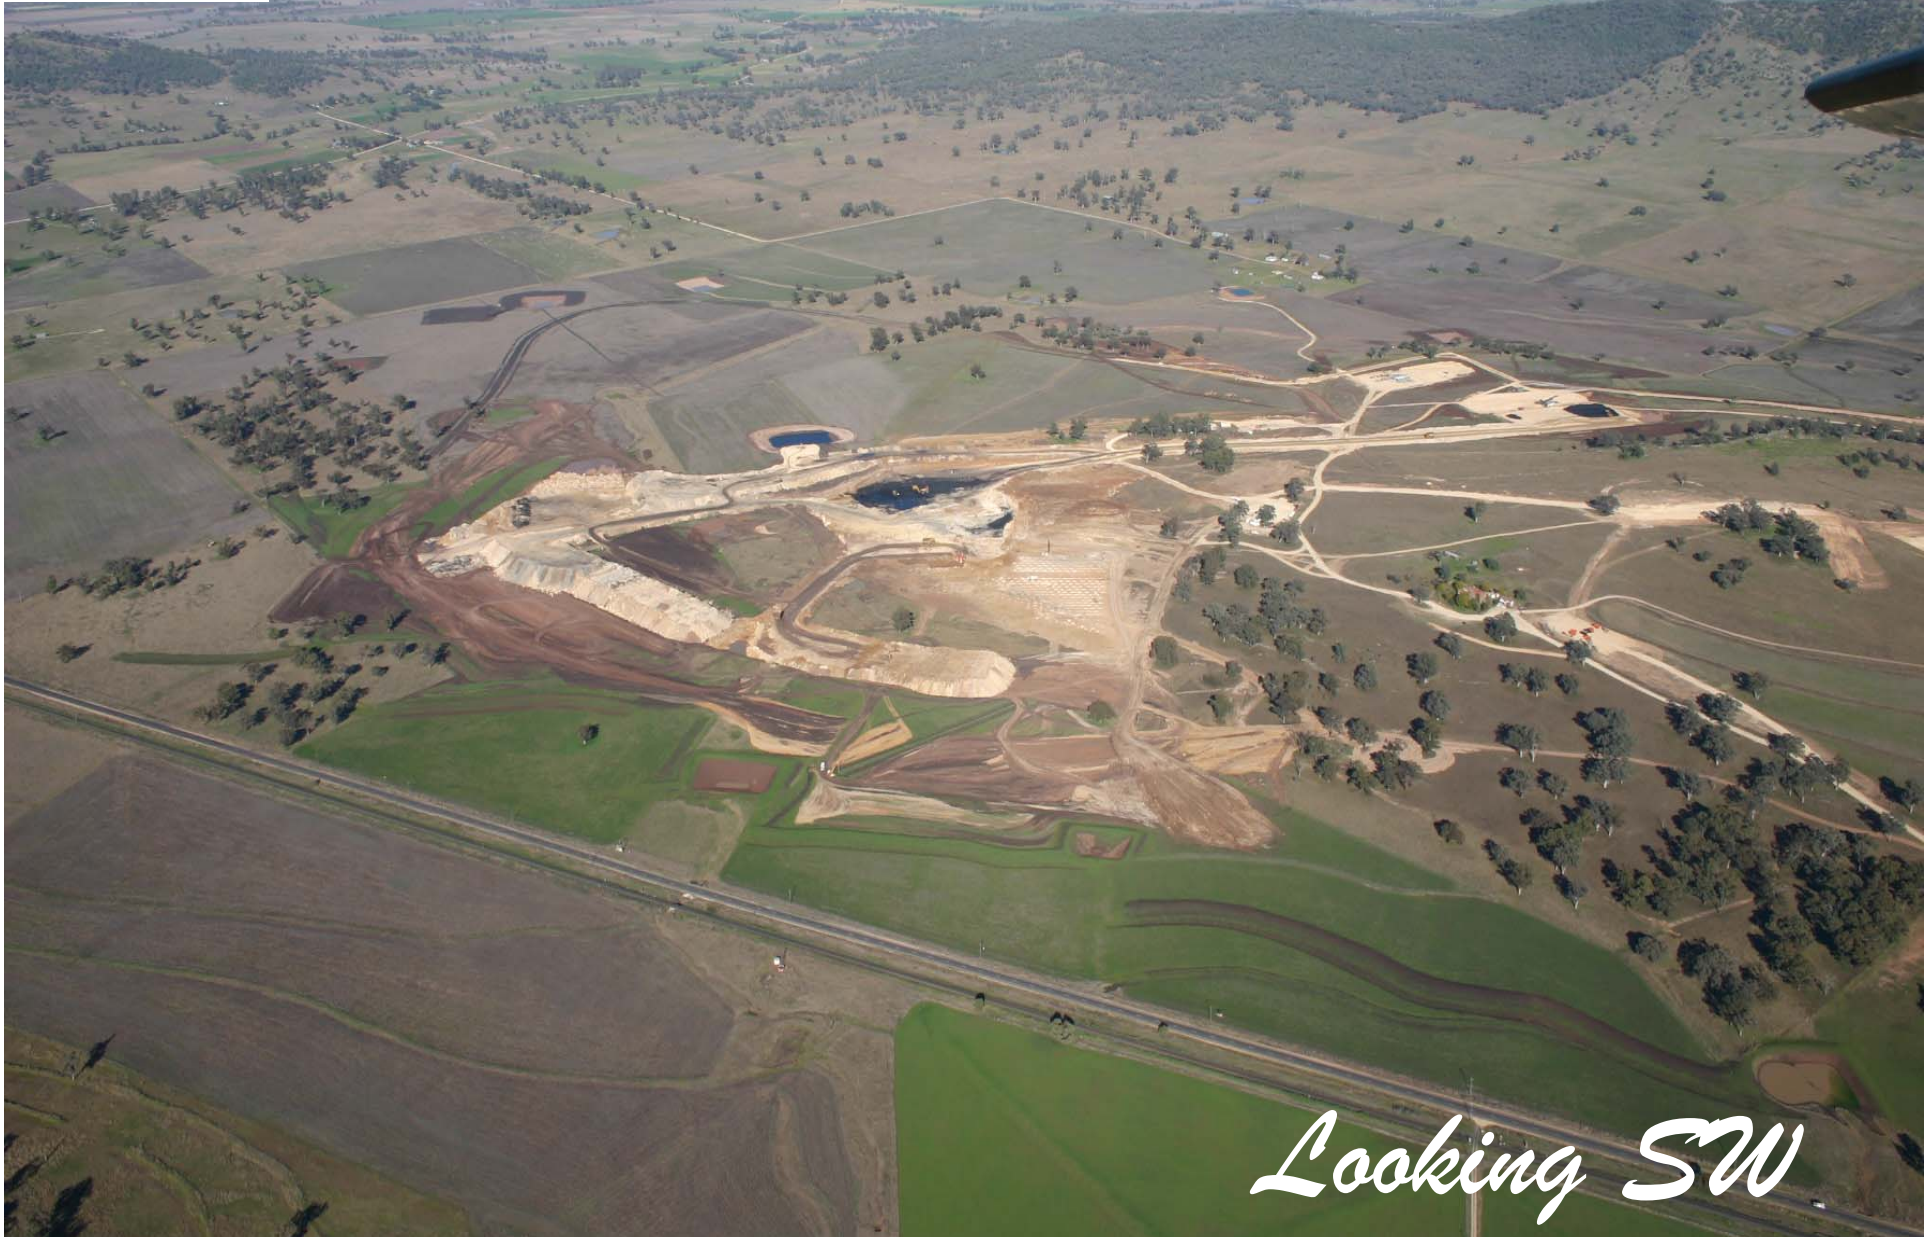
Water Management

Looking SW

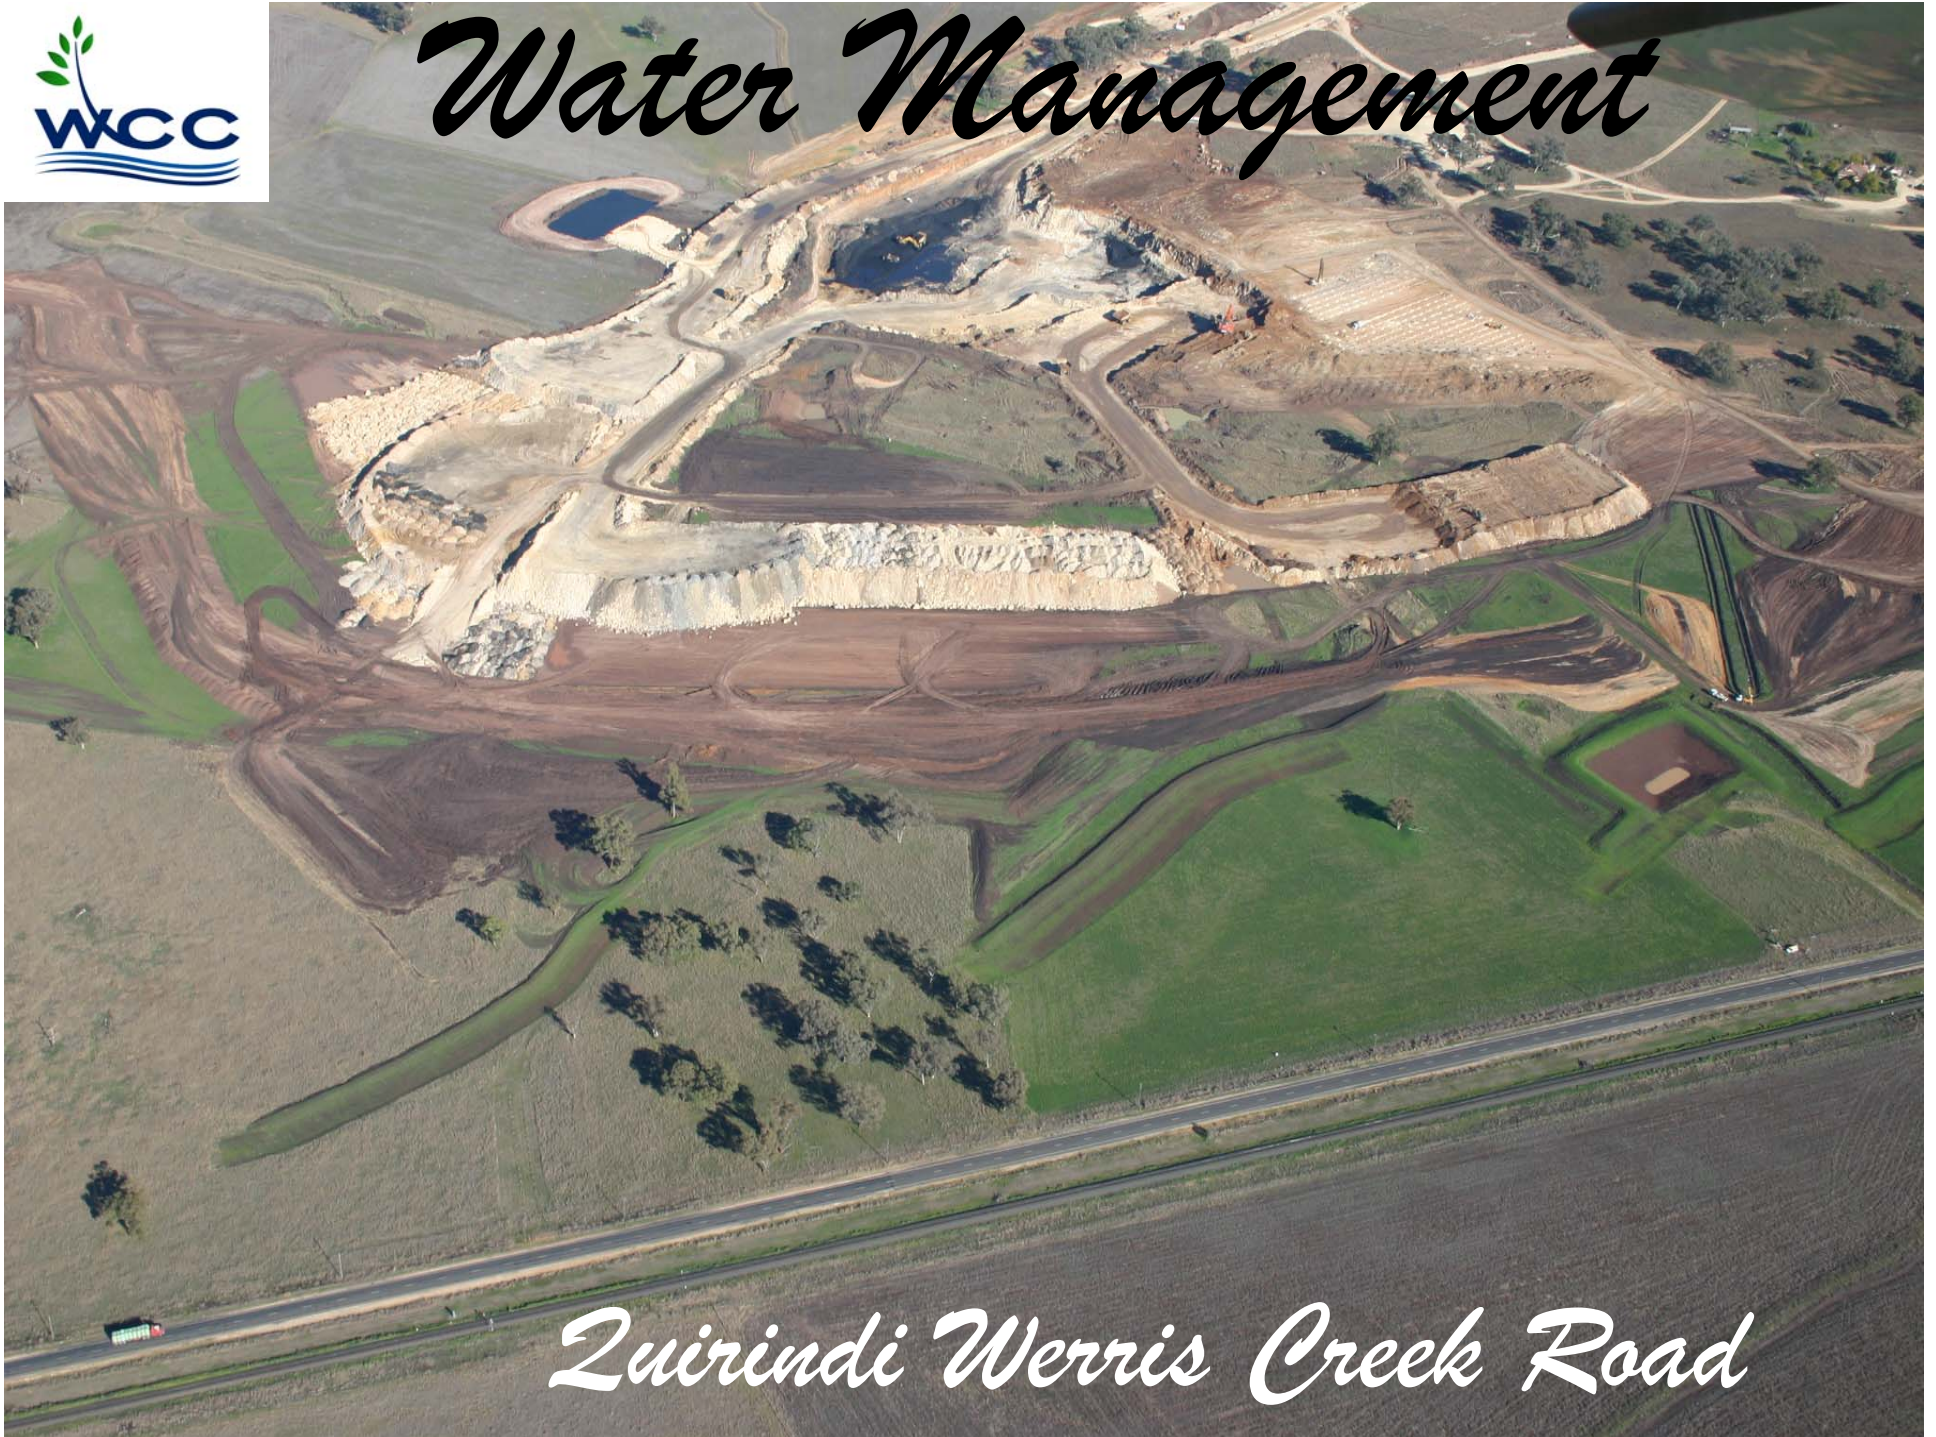
Water Management

Zuirindi Werris Creek Road

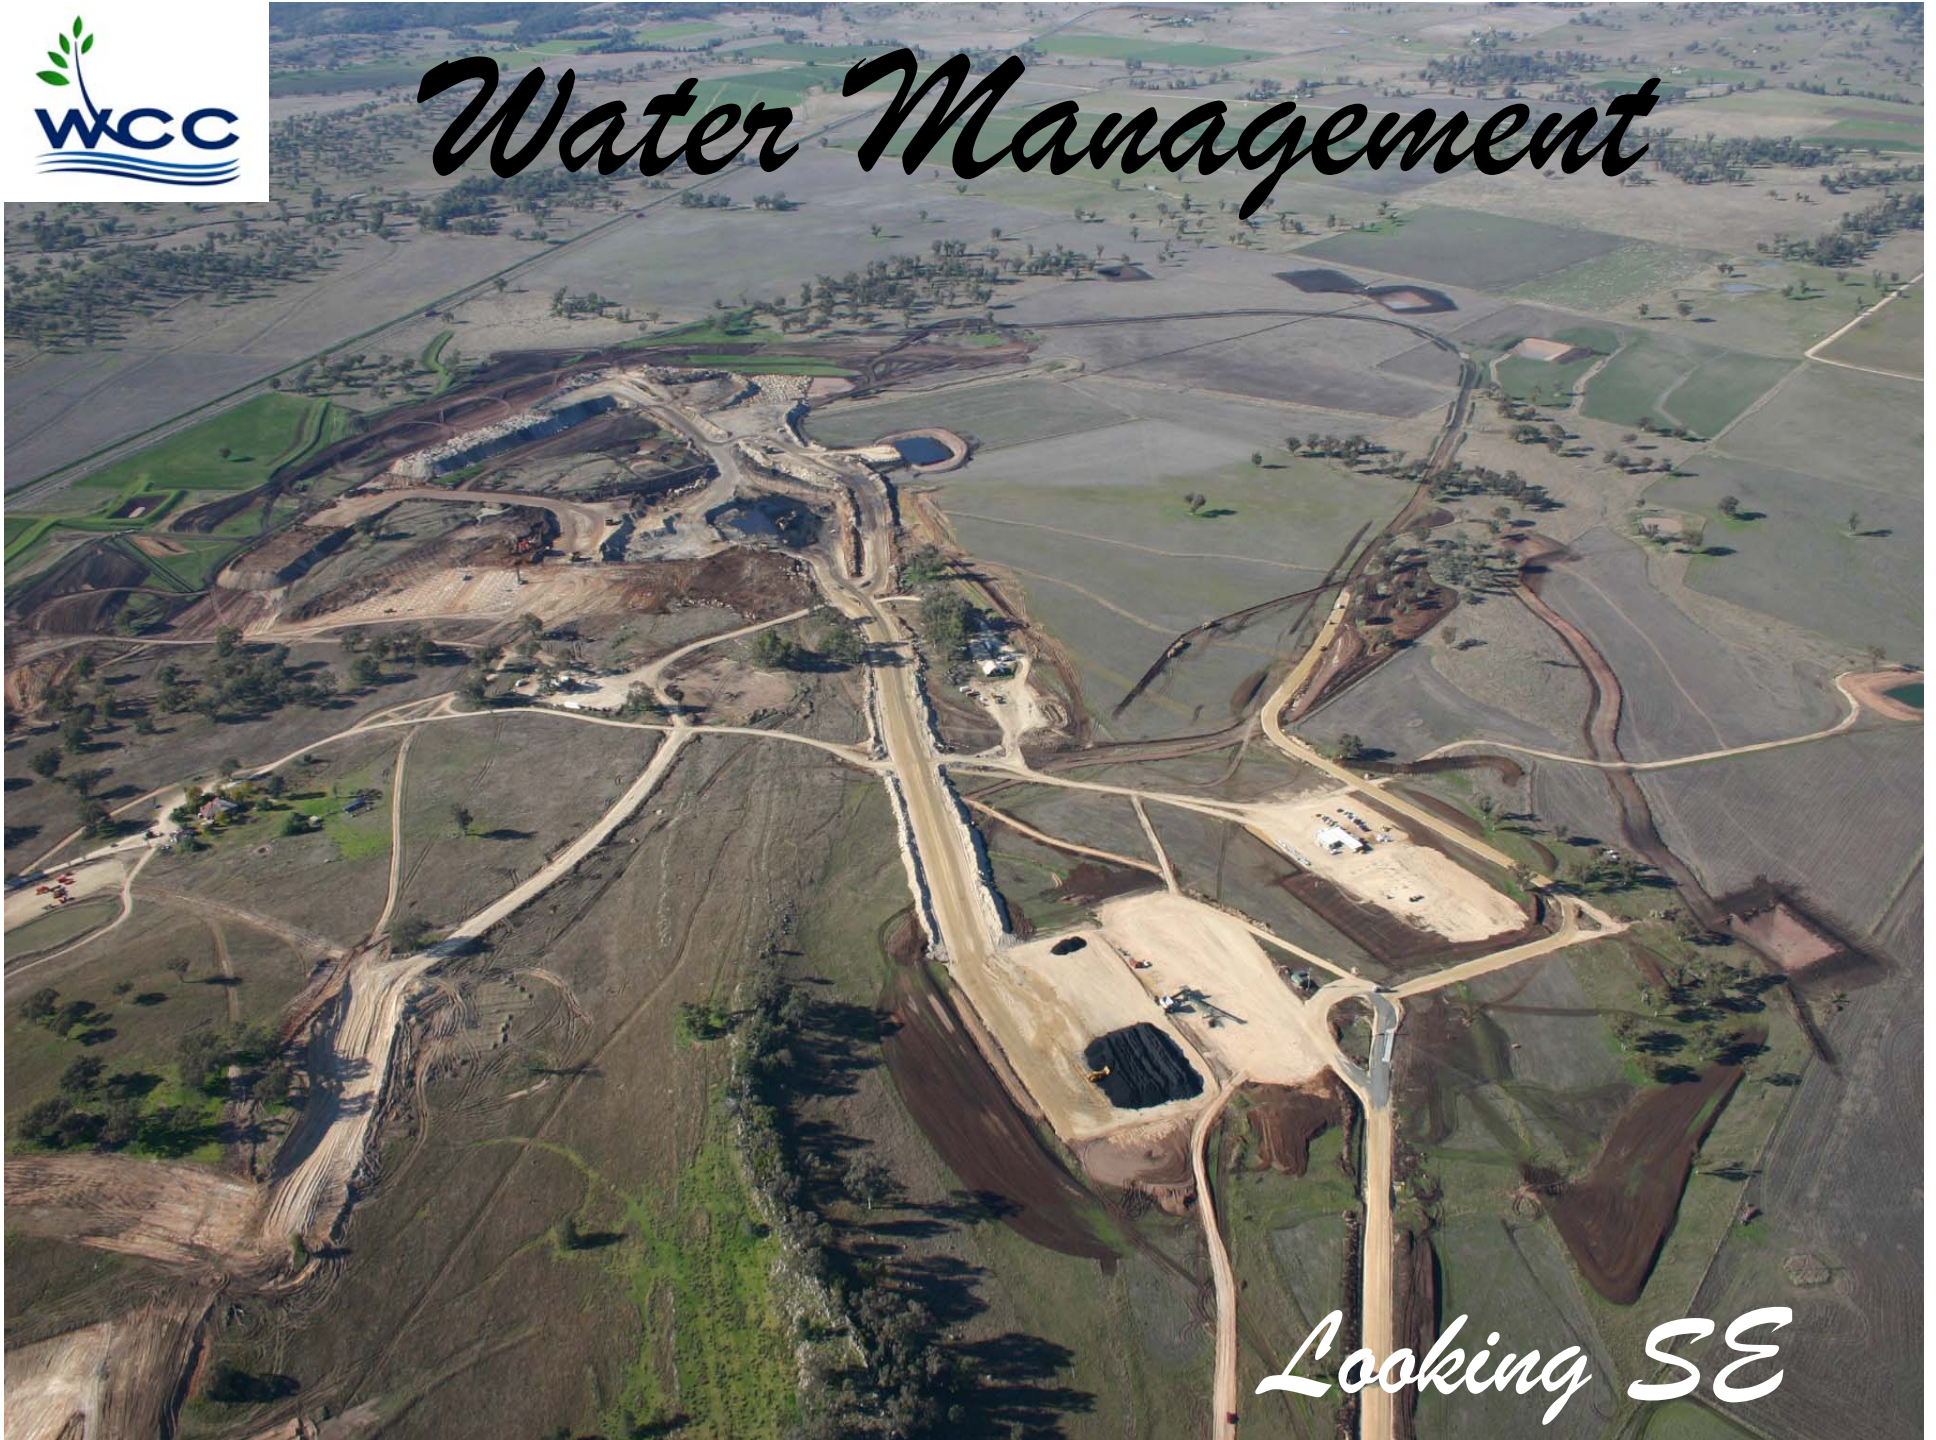
Water Management

Looking SE

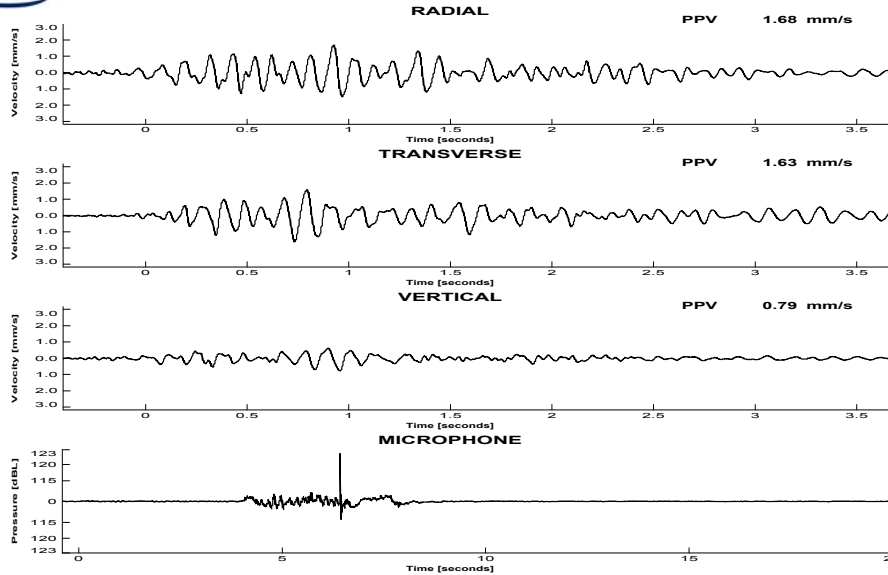
Blast Overpressure

21 Sep 2005

Blast overpressure criteria:

Less than 115dB 95% of blasts

Not to exceed 120dB

Pattern Type	: Staggered	Max. Inst. Charge	: 420 kgs
Pattern Size (m)	: 6 x 7.5mtrs	Explosive (Type & Weight)	a)
Designed Tonnage	: 61,563 kgs	b) AnFO at .8	
Bench Height (m)	: 10 - 20 mtrs	c) .	
Number of Rows	: 17	Delay Type - Electronic	
Number of Holes	: 218	- Average Interval (ms):	10ms
Blasthole Dia. (mm)	: 200mm	- Duration (ms) :	2170ms
Stemming (m)	: 4mtrs		
Sub Drill	: 0

Peak Vector Sum Velocity : 1.81 mm/s
Peak Overpressure : 122.3 dBL

Blast Overpressure Exceedance

Reported to EPA 21/09/05
