# Werris Creek Coal Mine

# Community Consultative Committee

22 AUGUST 2006

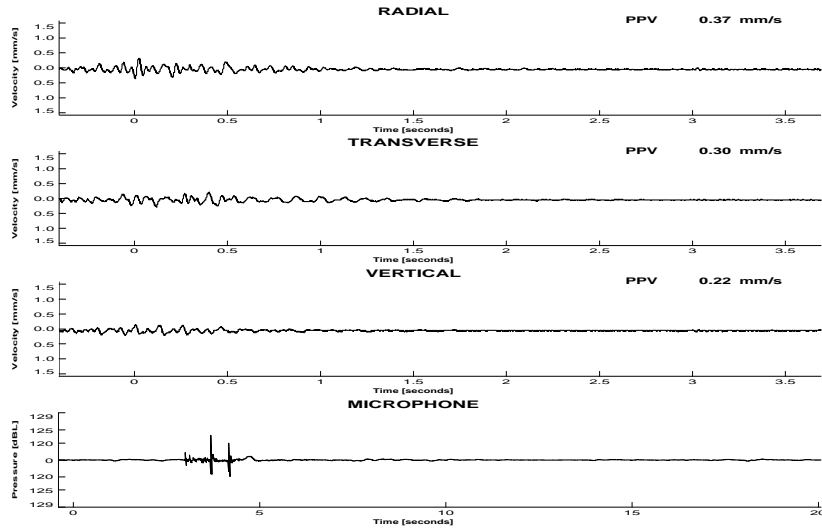
Time: 13:13:38 Monitor Location: Hillview  
 Date: 04 Jul 2006 Blast No/Id: WC66\_sh63

## Blast Overpressure 04 July 2006

Blast overpressure criteria:  
 Less than 115dB(L) 95% of blasts  
 Not to exceed 120dB(L)

Pattern Type	: Staggered	Max. Inst. Charge	: 240kgs
Pattern Size (m)	: 4.5 x 5	Explosive (Type & Weight)	
Designed Tonnage	: 5708 kgs	a) TM830 @ 1.2 g/cc	
Bench Height (m)	: 1.8 – 7 mtrs	b)	
Number of Rows	: 10	c)	
Number of Holes	: 192	Delay Type - Electronic	
Blasthole Dia. (mm)	: 171mm	- Average Interval (ms):	9.42 ms
Stemming (m)	: 1.8 – 3.0 mtrs	- Duration (ms)	: 1800 ms
Sub Drill	: 0

Peak Vector Sum Velocity : 0.40 mm/s  
 Peak Overpressure : 123.3 dB(L)

*Blast Overpressure Exceedance*

*Reported to EPA 04/07/06*
