WHITEHAVEN COAL

**Annual
Environmental
Management
Report**

**Rocglen Coal
Mine
(ML 1620)**

1 August 2009 – 31 July 2010

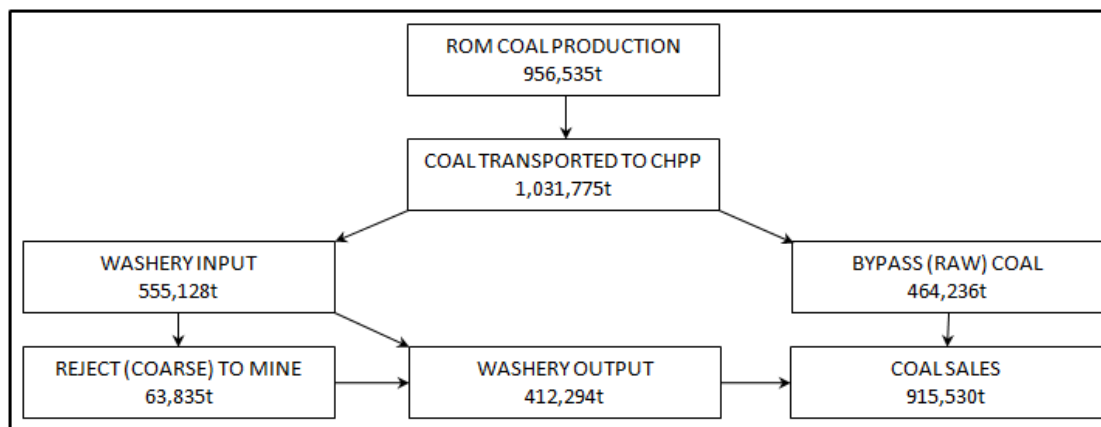
**Figure 2 - Coal Movement and Production Summary
(2009/2010 Reporting Period)**

No changes or additions to the process or facilities occurred during the reporting period. The coal movement and production summary is shown in Figure 2.

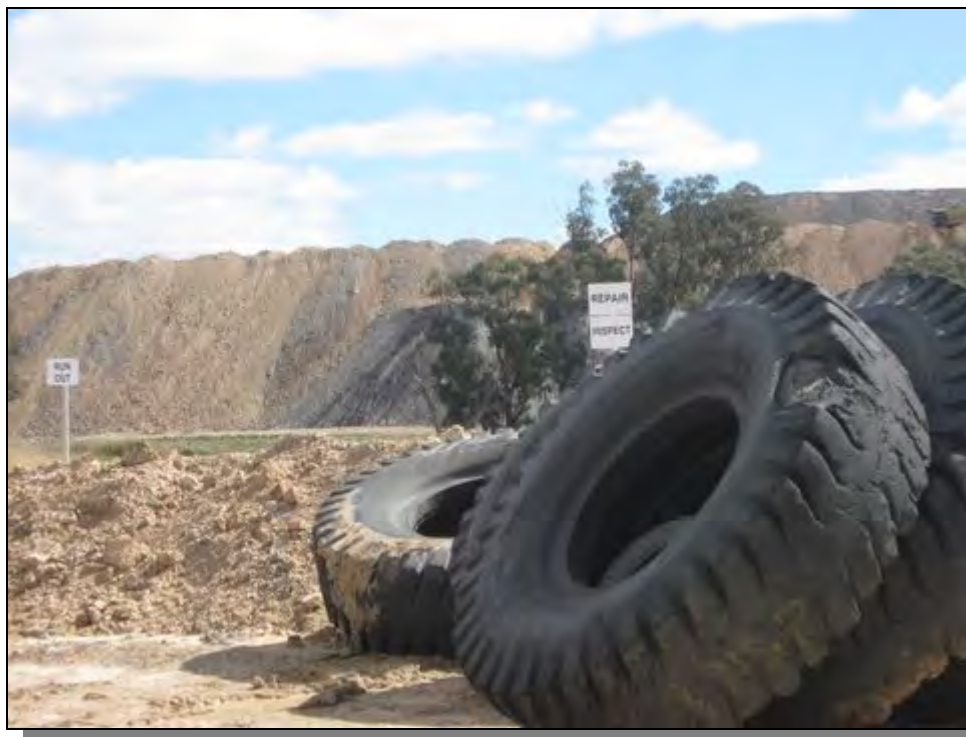
Plate 1 - Tyre Storage Area

Mine equipment tyres are retained (stored) on site until disposal within the open cut void. To date, no tyres have been disposed of in pit. Approximately 20 tyres are currently stockpiled for future disposal. During an inspection by I&I NSW in July 2009, it was noted that improvements could be made in relation to waste segregation. During the reporting period, Rocglen developed a designated tyre storage area with signage to separate different tyres (Plate 1).

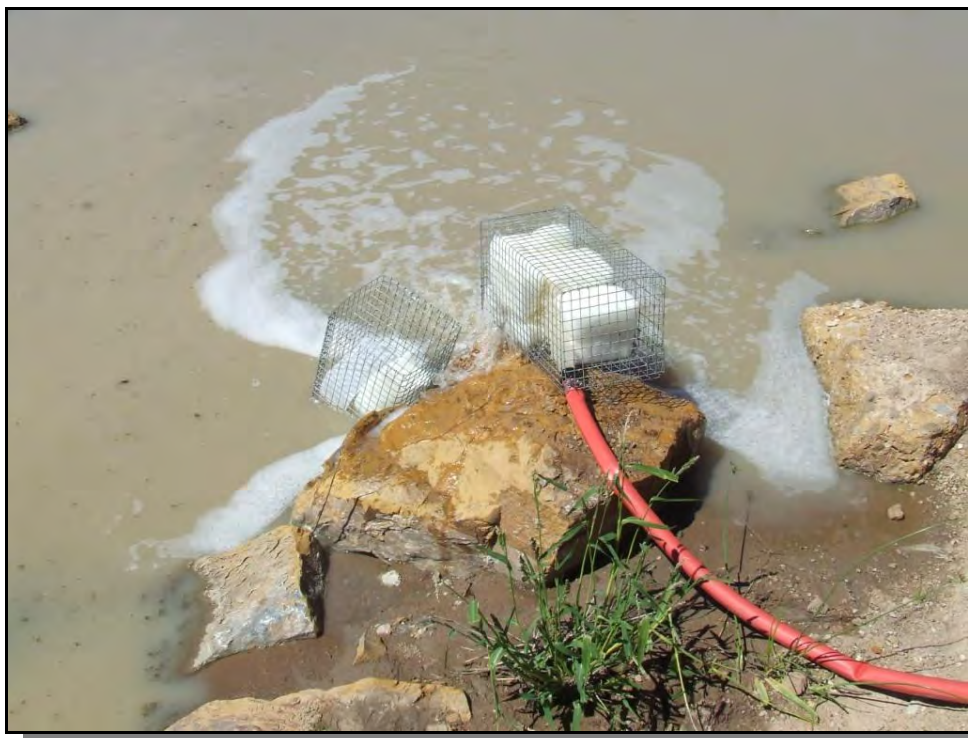
Plate 2 - Flocculant Blocks Used in SD3

Due to the ongoing issues with elevated TSS levels in discharge waters from SD3, Rocglen implemented the use of DamClear Flocculant Blocks (floc blocks) in March 2010. This involved the placement of blocks on the inflow of SD3 and the pumping/recirculation of water through the blocks to activate the flocculant within the dam (Plate 2). The blocks visibly reduced the sediment level at the surface of the water.

A controlled discharge was planned in late March 2010 to increase the storage capacity in SD3. However, water quality analysis conducted on the 25th March 2010 indicated that the floc blocks had not sufficiently reduced to the TSS level to comply with the concentration threshold of 50mg/L (sample result – 58mg/L). As a result, a discharge was not able to be conducted and the dam subsequently discharged during a rainfall event, with a total amount of 16.8mm recorded at the Rocglen weather station. This total is approximately 10mm less than that recorded at the Canyon Mine (28.4mm), Tarrawonga Mine (29.0mm) and Gunnedah BOM weather station (29.8mm).

Investigations into further measures for controlling future discharge events have included the option for an additional water storage structure downstream of SD3 and the possibility of further trapping of sediment by placing a polymer concrete liner on the inflow to SD3. Works on construction of an additional storage downstream of SD3 have not been able to commence due to ongoing wet conditions with machinery unable to access the proposed dam site. With regard to the installation of a polymer concrete liner on the inflow to SD3, the installation of this has had to be delayed on numerous occasions due to the water levels in the dam and inability to access the inflow drain to complete required shaping works in advance of placement of the liner. More recently, in an effort to provide a more immediate solution to sediment loads, water samples have been referred to a supplier to analyse the water quality to identify an appropriate liquid flocculant and appropriate dosage rate which could be used to provide a more efficient settlement process.

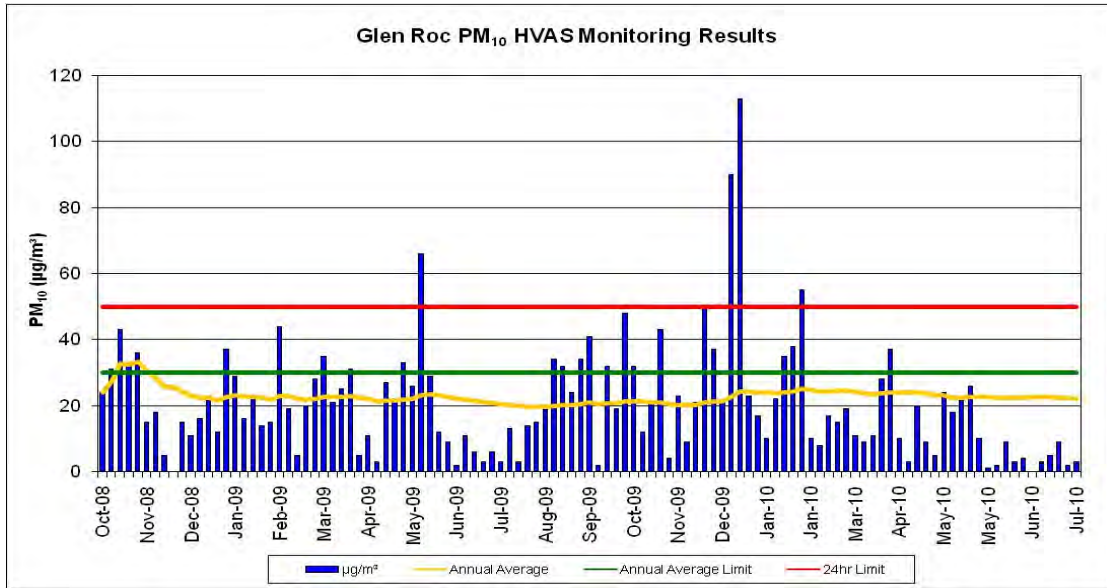
Figure 5 - Glenroc HVAS PM₁₀ Data

The long term PM_{10} levels and averages are provided in Figure 5 and Figure 6. Both figures show a relatively consistent annual average which increased slightly following the elevated results in September/October 2009 (from regional dusty conditions) and December 2010 (from the Kelvin Range bushfire). The annual average at both locations decreased towards the end of the reporting period as a result of the ongoing low PM_{10} levels recorded during May – July 2010.

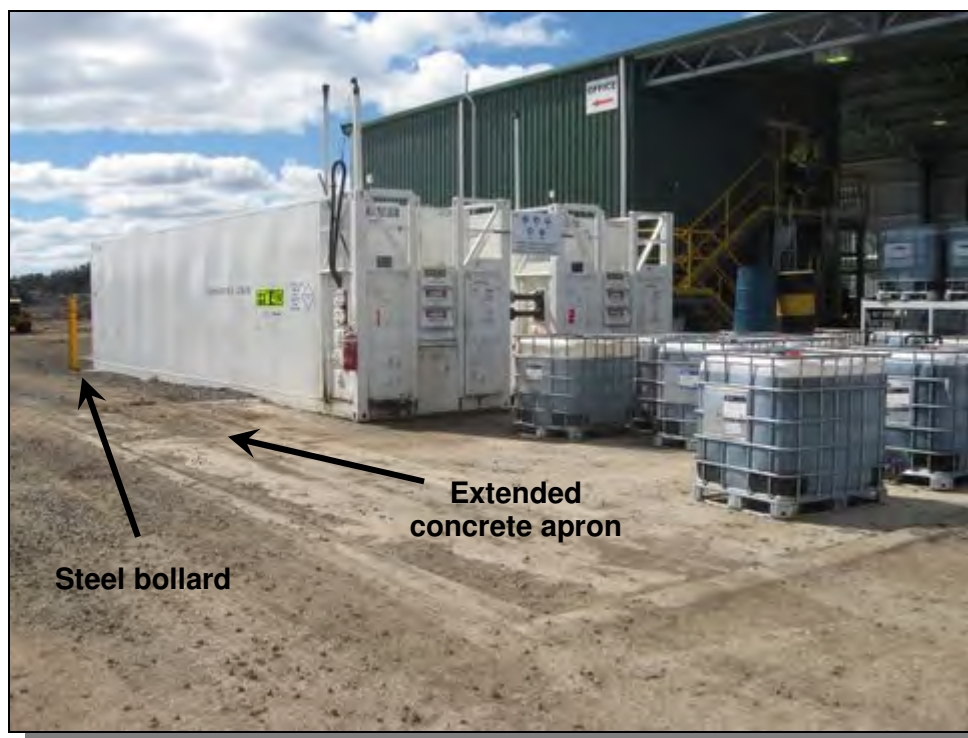
Plate 3 - Extended Concrete Apron at Refuelling Bay

The DPI (now I&I NSW) undertook a site visit in July 2009 and identified that hydrocarbon management activities at the workshop required improvements. Additional concrete bunding has since been installed at the re-fuelling (Plate 3), oil-water separator and hydrocarbon storage areas to reduce the likelihood of soil and water contamination. A steel bollard has also been erected adjacent to the northern end of the fuel tank, following a suggestion from the then DPI in July 2009 that the fuel tank should be protected from approaching vehicles (Plate 3).

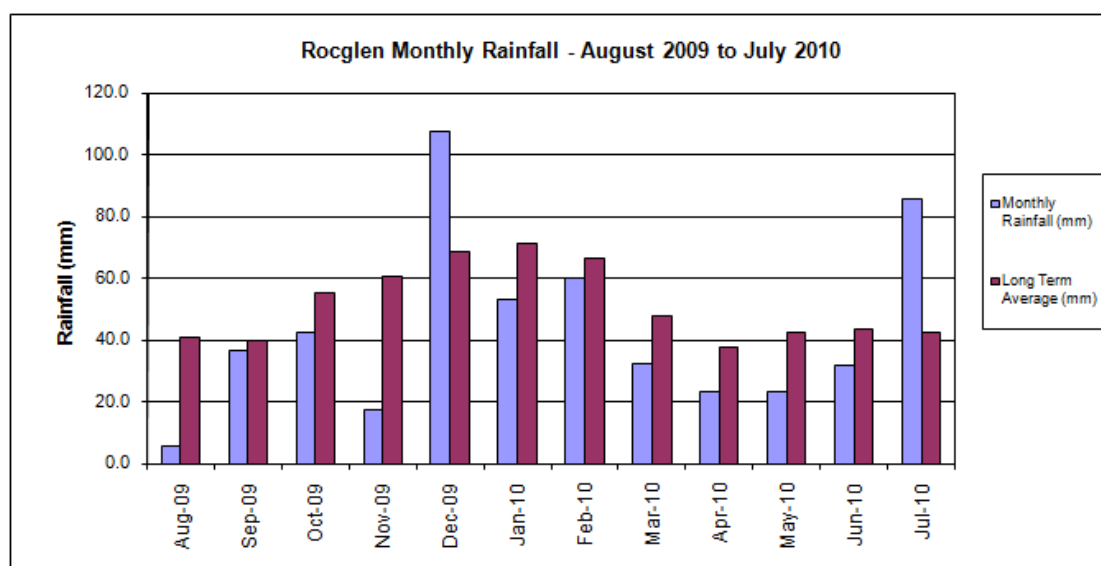
Figure 7 – Monthly Rainfall Data

A review of Table 12 and Figure 7 shows that the total rainfall at the mine during the reporting period was 521.4mm, compared to a long term average of 618.4mm at Gunnedah and 647.8mm recorded in the previous reporting period. It is believed that the total rainfall recorded by the meteorological station does not fully represent the actual rainfall received. The Bureau of Meteorology station at the Gunnedah Pool (055023) recorded 780.6mm for the same period whilst the Canyon Coal Mine meteorological station recorded 681.0mm. It is possible that the gauge did not accurately record rainfall data as a result of dust and other contaminants (grass, insects etc) obstructing the gauge. Data lost during a number of months (due to power failure) would have also contributed to the lower rainfall total. Whitehaven personnel now conduct monthly inspections of the weather station to ensure it is operating effectively. Boztek Solutions Pty Ltd are utilised for technical issues.

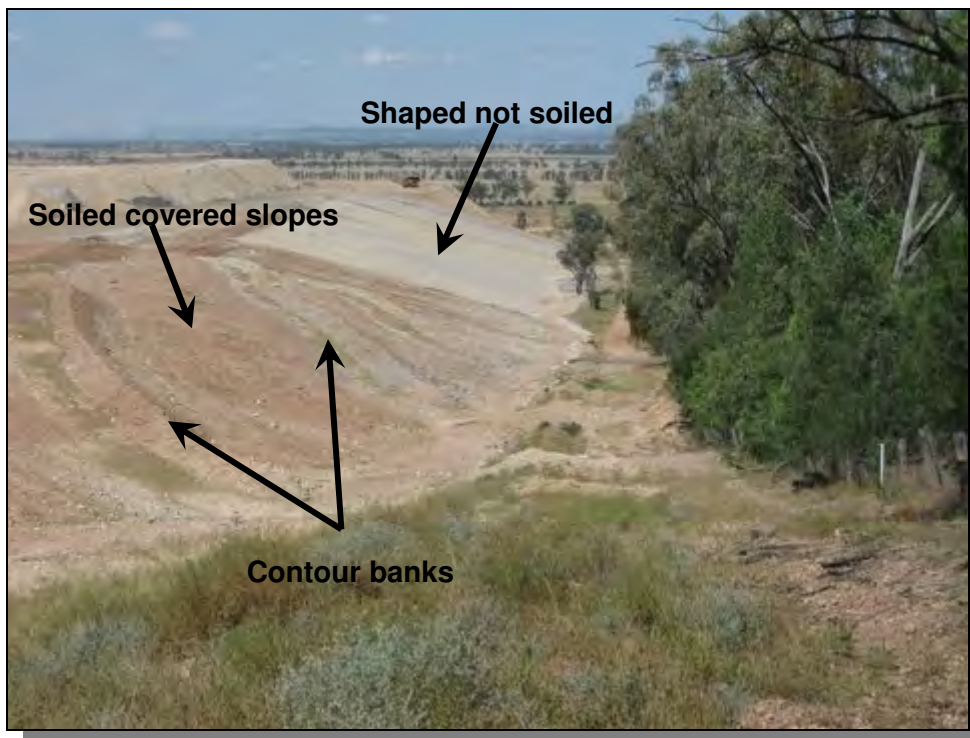
Plate 4 - Shaped Waste Emplacement and Contour Banks

Table 16 and Table 17 present a Rehabilitation Summary and listing of maintenance activities as required in the DMR Guidelines. Rehabilitation of disturbed land undertaken during the reporting period comprised reshaping approximately 5.2ha and reshaping and topsoiling approximately 5.2ha of the southern waste emplacement. Contour banks installed to direct runoff back to natural ground level (Plate 4) appear to be working well with minimum erosion occurring despite very little groundcover being present.

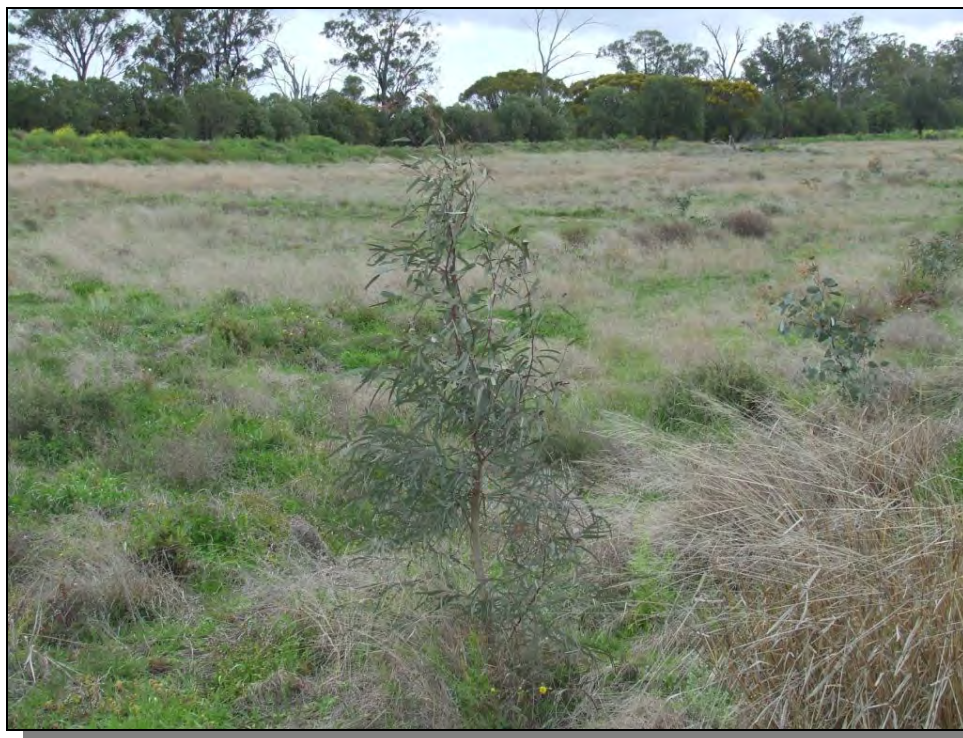
Plate 5 - Established Tubestock along Site Access Road

Besides cover crop establishment on soil stockpiles and the amenity bund, the only rehabilitation that occurred in the previous reporting period was planting of approximately 200 tubestock along the site access road to provide a future screening of the site from Riorden Road. The tubestock are now well established, as shown in Plate 5.
