**Annual  
Environmental  
Management  
Report**

**Rocglen Coal  
Mine  
(ML 1620)**

1 August 2010 – 31 July 2011

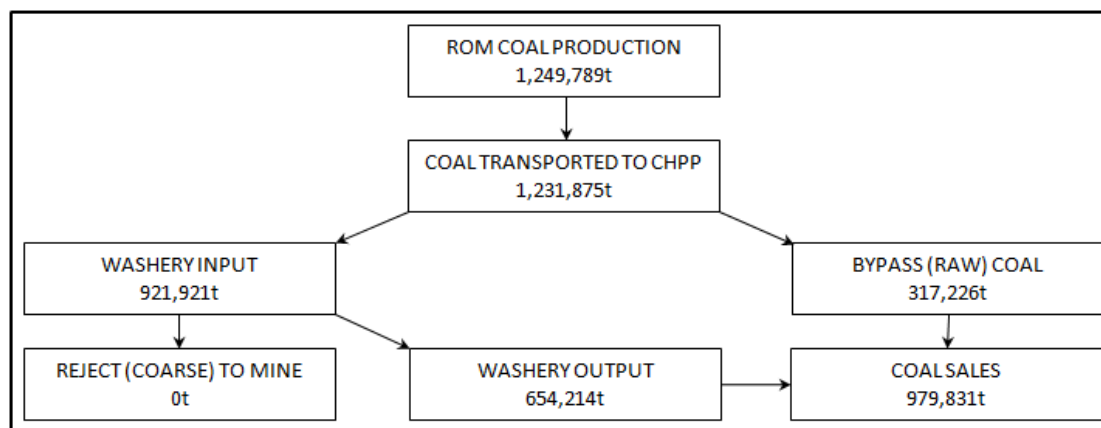
**Figure 2 - Coal Movement and Production Summary  
(2010/2011 Reporting Period)**

No changes or additions to the process or facilities occurred during the reporting period. The coal movement and production summary is shown in Figure 2.

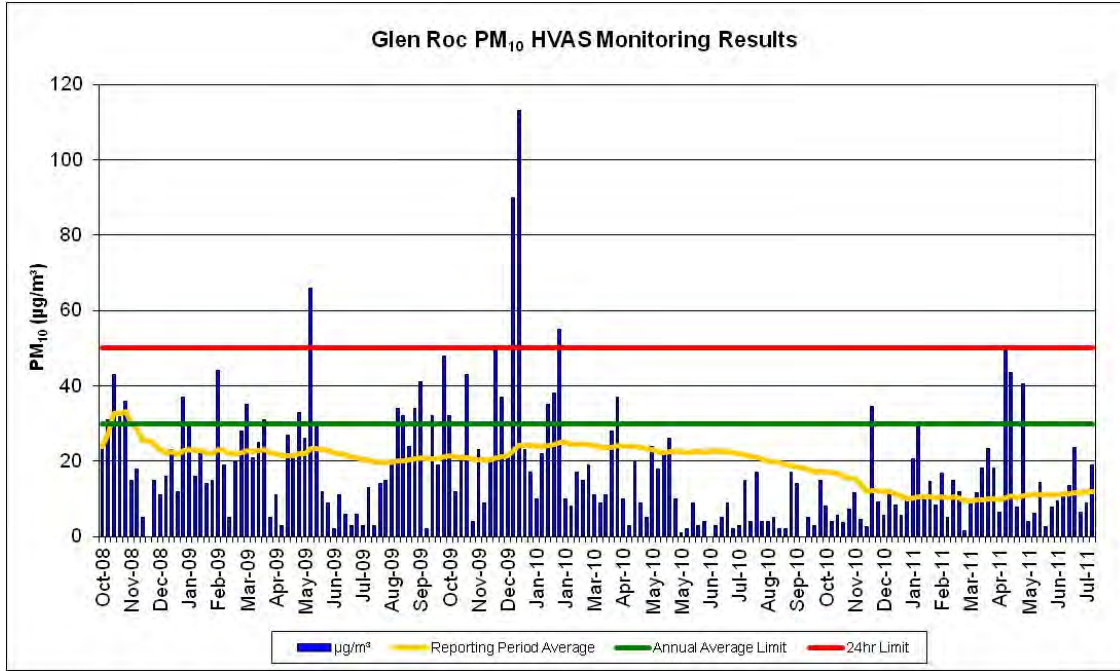
Figure 5 - Glenroc HVAS PM<sub>10</sub> Data

The long term PM<sub>10</sub> levels and averages are provided in Figure 5 and Figure 6. Both figures indicate a reduction in annual average PM<sub>10</sub> level. This is due to the exclusion of elevated results that no longer fall within the 12 month reporting period. These include those from September/October 2009 (from regional dusty conditions) and December 2009 (from the Kelvin Range bushfire).

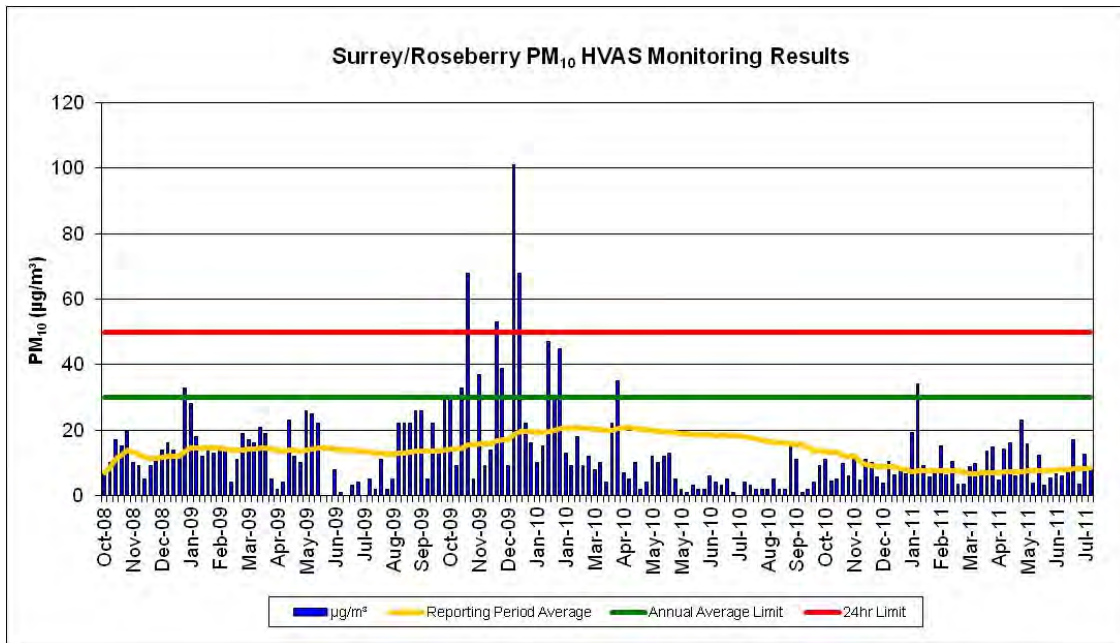
Figure 6 – Surrey/Roseberry HVAS PM<sub>10</sub> Data

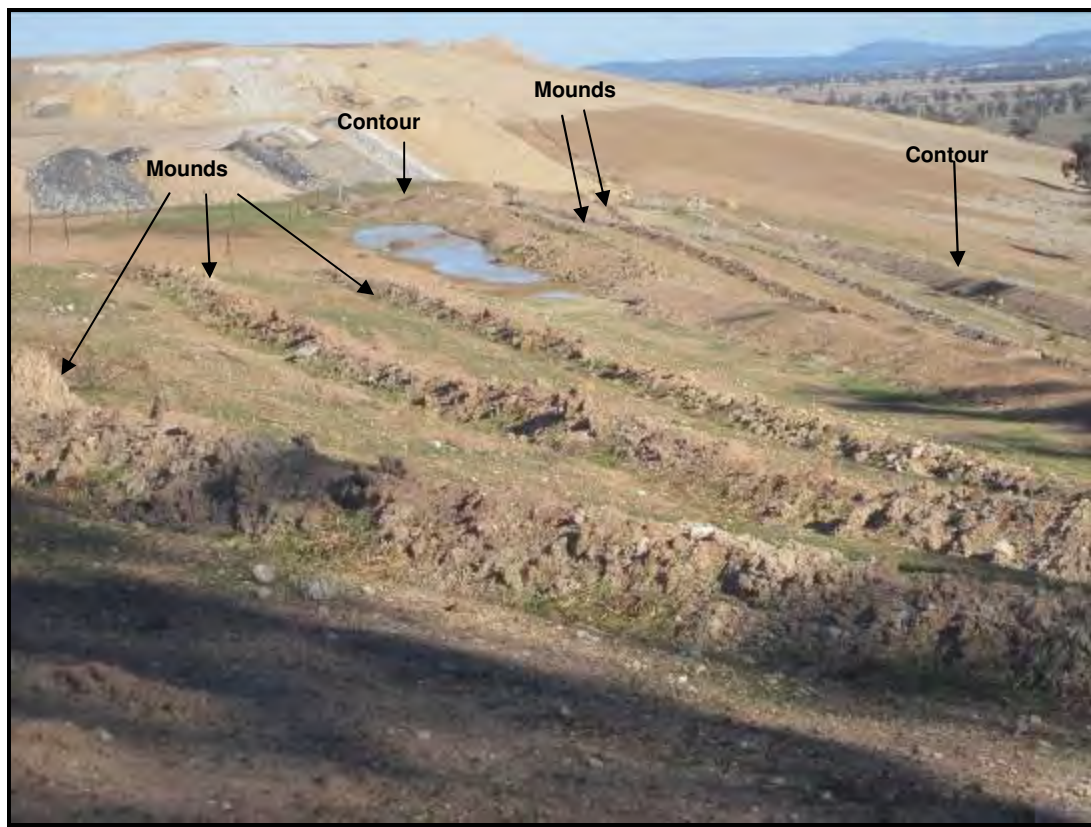
Plate 2 - Mounding used to catch runoff and minimise erosion

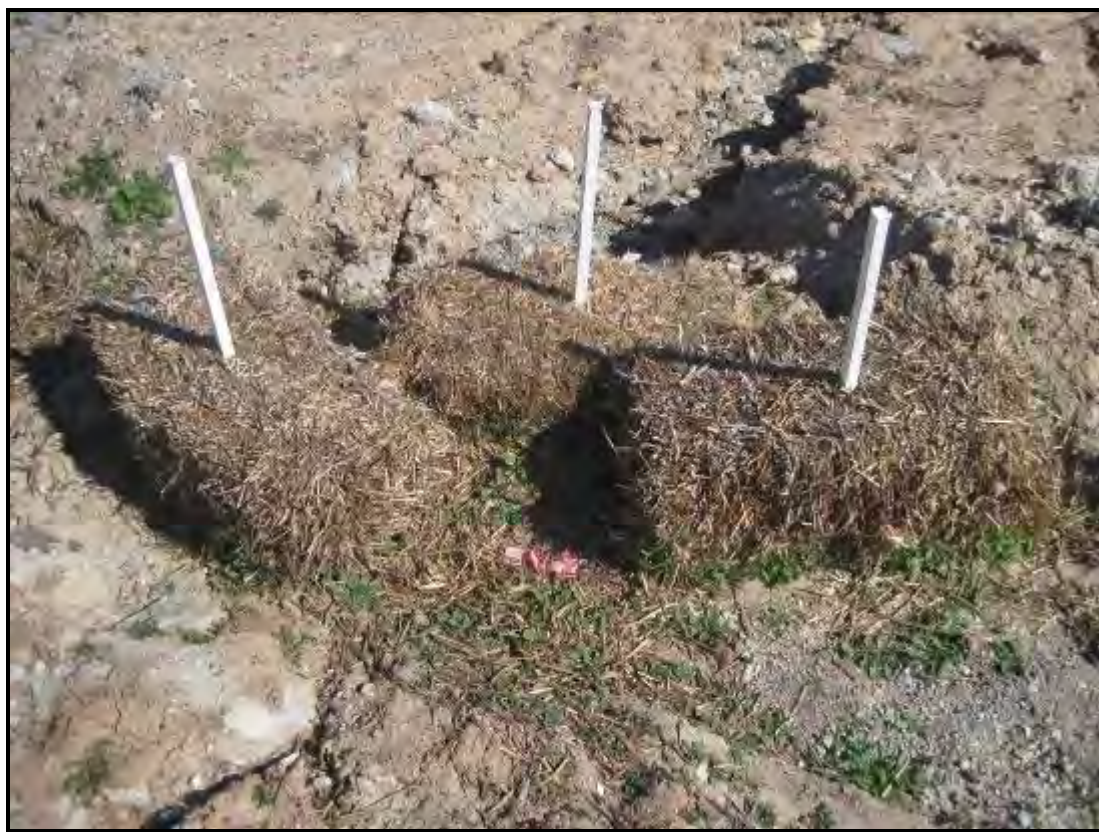
Plate 3 – Hay bales used to control erosion and sedimentation

The site has maintained sediment fencing in appropriate locations throughout the reporting period, particularly at the two discharge locations. This incorporated the use of hay bales as additional sediment traps at these locations. Hay bales have also been utilised on rehabilitation slopes in order to 'patch' erosion channels through contours and mounds. Mounding was used as an alternative to rip lines with the aim to catch more water on-slope hence reducing runoff and erosion whilst aiding fast root establishment through increased moisture within the soil profile (Plate 2). Whilst the sampling results have indicated elevated sediment loads in the first half of the reporting period, site personnel have made every effort to try to minimise sediment loading in surface waters in difficult circumstances given the extent of regular rainfall.

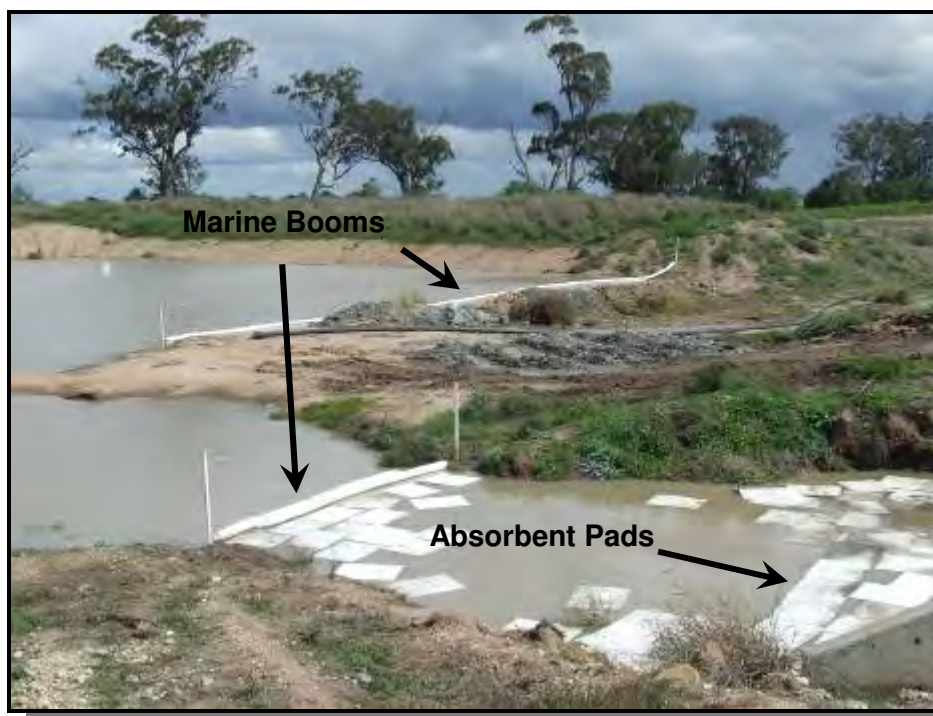
One spill occurred over the reporting period involving a diesel leak into the surface water storage SB19 which overflows into the southern discharge point SD3. The leak was noticed on the 6<sup>th</sup> September 2010 on regular inspection of surface water storages. The three phase system was immediately put into place with the following actions taking place to control the spill:

Plate 4 – Containing and removing diesel slick from SD 3

- Phase 1: Initial Recovery: It was identified that the fuel leak was coming from a diesel pump used to fill water carts from SB19. The pump was immediately

removed for repair and fuel/oil absorbent pads were immediately placed around the area the pump was sitting.

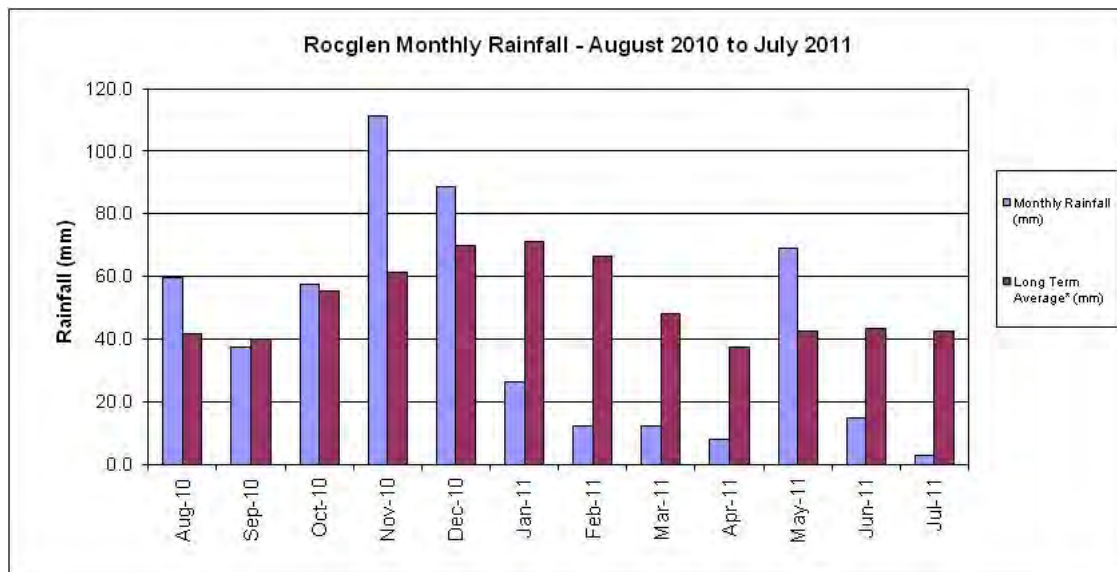
Figure 7 – Monthly Rainfall Data

A review of Table 13 and Figure 7 shows that the total rainfall at the mine during the reporting period was 501.0mm, compared to a long term average of 619.7mm at Gunnedah and 521.4.mm (lower than expected result due to battery issues – Gunnedah Pool BOM recorded 780.6mm) recorded in the previous reporting period. Figure 7 also depicts the heavy rainfall events received over the first half of the reporting period as compared to the drier months from January 2011 (disregarding May 2011).

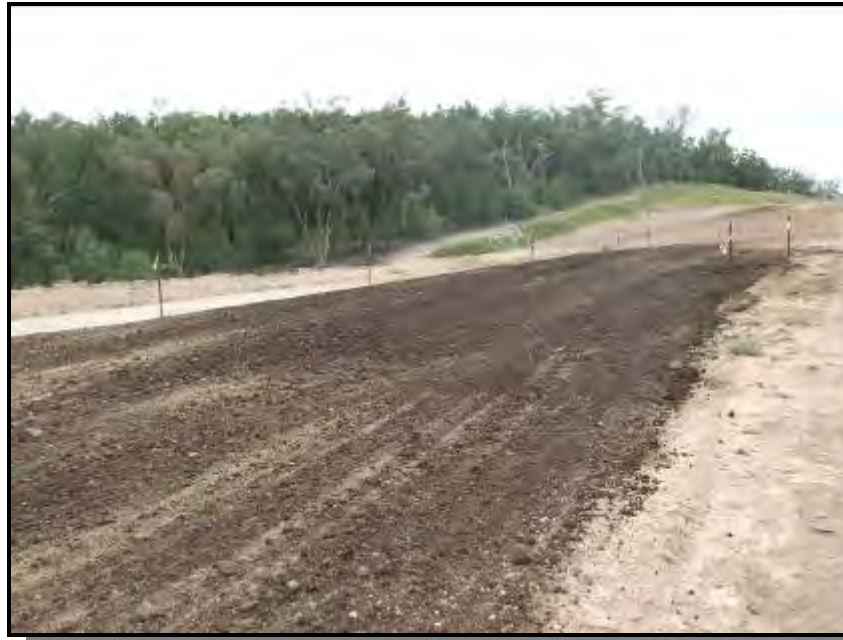
**Manure compost trial:** The trial was set up in November 2010 in order to investigate the success of mixing summer/winter pasture seeds and eucalypt seeds into a chicken manure based compost. The product was spread over the topsoil and provided a layer for the mixed seed to germinate within (Plate 5). At the time of the trial the remaining rehabilitation area was seeded with Japanese Millet and fertilised with Granulock 15 to provide a comparison with the compost trial. Over the following summer months low rainfall resulted in a failed millet crop and similarly no vegetation established within the trial area. Continued monitoring has shown signs of plant growth within the trial area over the winter period, however this was predominately identified as broadleaf weed (Plate 6). Although not desirable, the growth of weeds does indicate increased fertility. Consultation will continue with the suppliers in order to further investigate this rehabilitation option.

**Plate 5 – Manure compost trial**

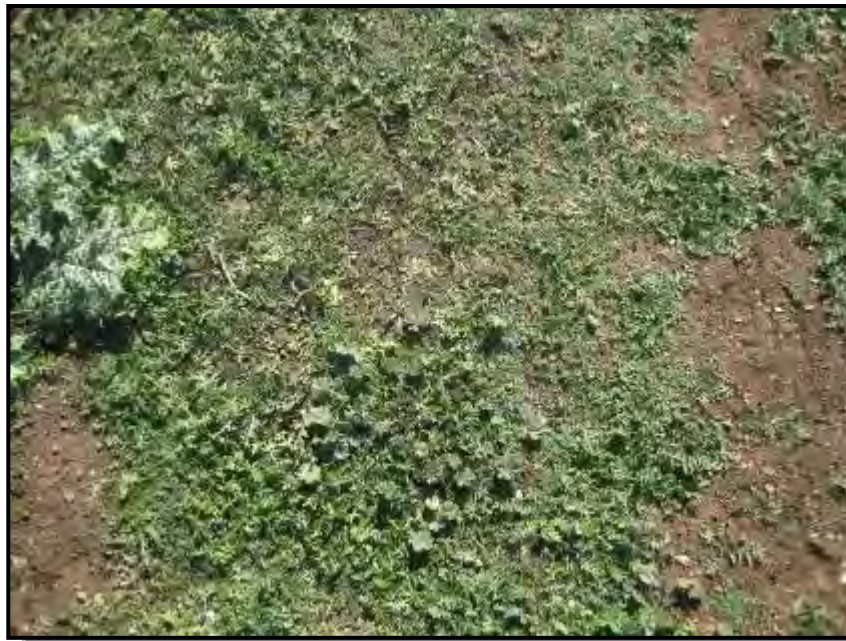
**Plate 6 – Growth eight months after manure trial**

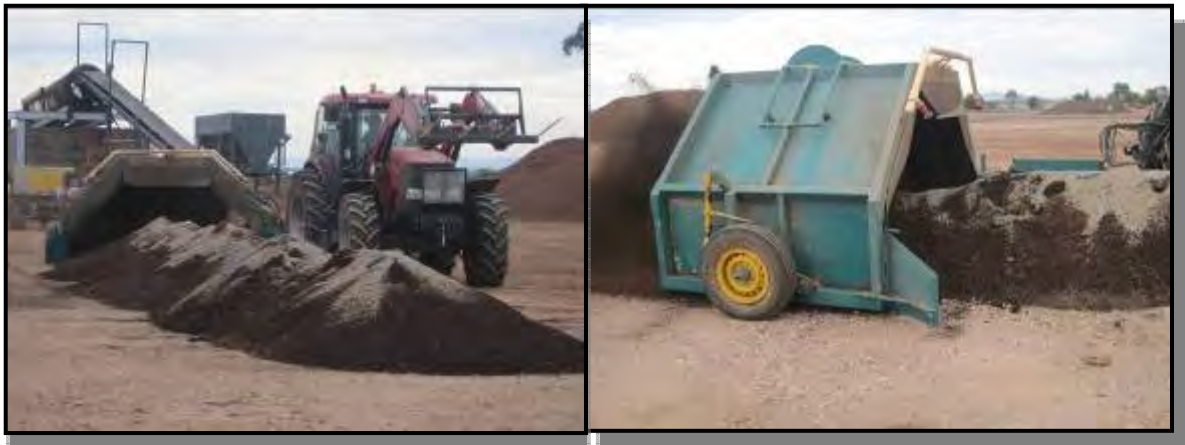
**Humus Compost trial:** After a failed attempt to establish a summer cover crop, investigation was undertaken into alternative methods to establishing cover within the area. Whitehaven began consulting with local agronomists from Cotton Grower Services (CGS) in order to establish better understanding of the state of the soil and best possible planting methods. After soil analysis by CGS it was determined that the rehabilitation area had a high pH, was low in organic matter, low in soil microbes and required additional treatment.

**Plate 7 - Mixing seed with humus compost**

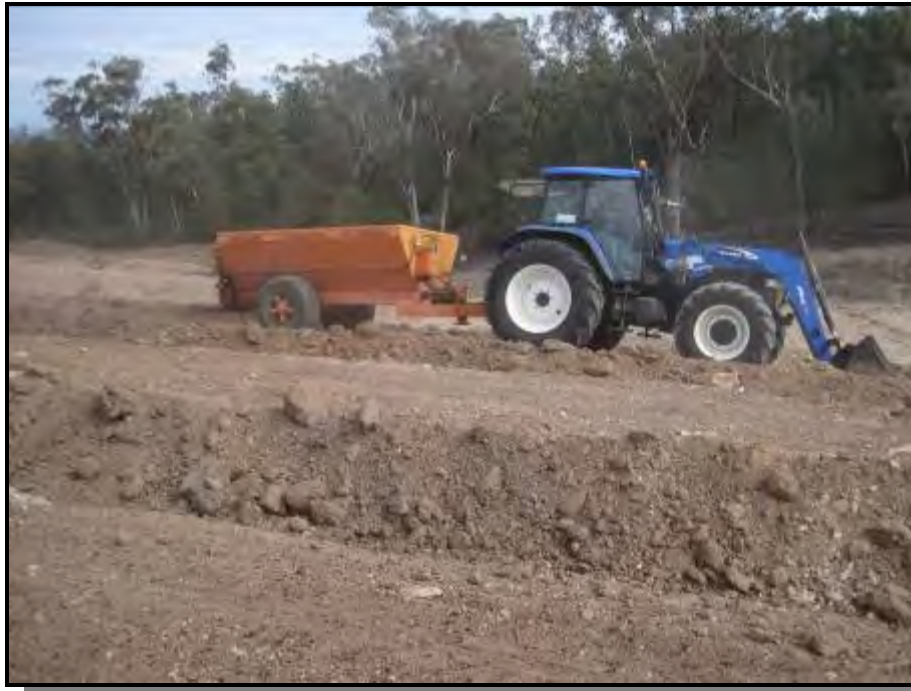
The seed/compost mix was applied to the entire topsoiled area using a tractor and spreader at a rate of 6 m<sup>3</sup>/ha on the 2<sup>nd</sup> May 2011 (Plate 8). The trial gave reasonable establishment (Plate 9), however given poor rainfall over recent months it failed to maintain adequate cover. The crop was also pressured by continual grazing from Kangaroos entering site via the adjacent Vickery State Forest. It was not uncommon to observe 10-15 Kangaroos on the pasture during an inspection in the middle of the day.

Plate 8 – Applying seed compost mix between tree mounds

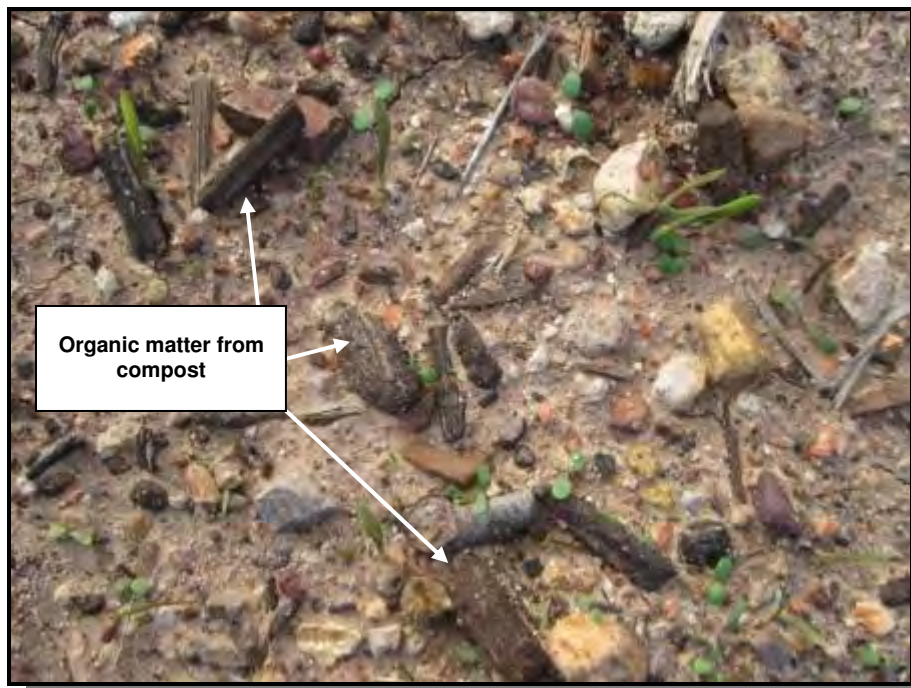
Plate 9 – Germination one month

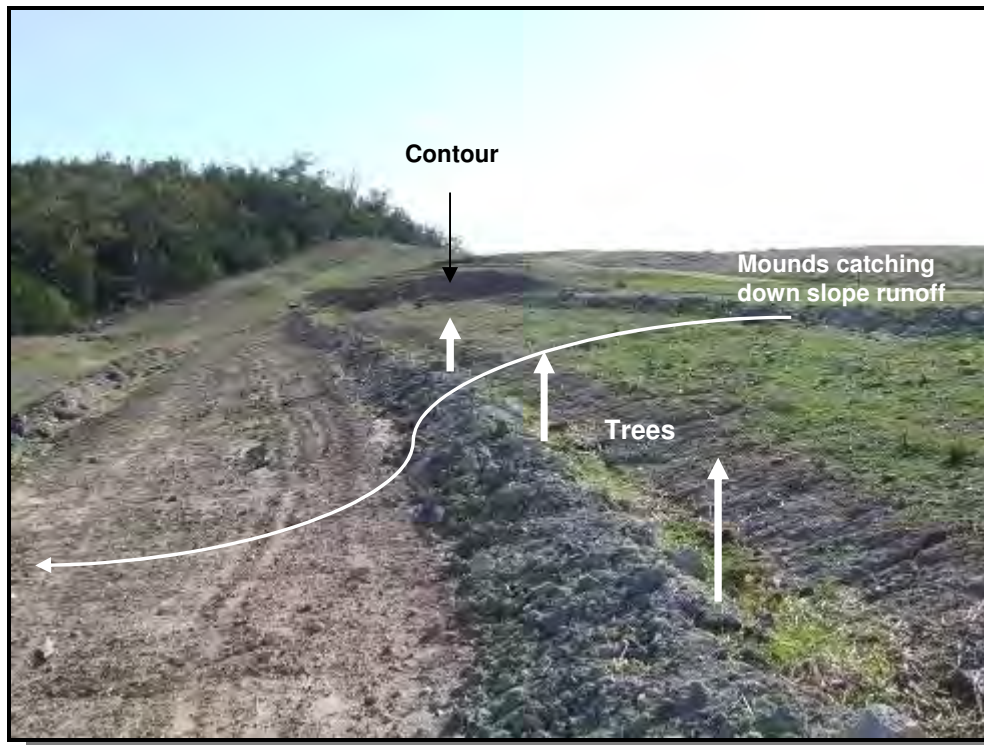
**Mounding:** Prior to the humus compost/seed application, earthworks were carried out by G&B Ward Earthmoving in order to stabilise and mound smaller inter-contours on the slope. The aim of mounding is to hold as much water as possible on the rehab slope, thereby further reducing runoff and erosion and providing a medium for planting trees during the winter (Plate 10). This also leads to less water draining into

sediment dams and thus is also a measure to help reduce discharges from site. The method has proved effective with desirable tree growth to date, and although some instances of erosion can be noted, pools of water can be sited behind the mounds for up to 2-3 weeks after rainfall events.

Plate 10 – Mounding on Western Rehabilitation Area 30/6/2011
