TARRAWONGA COAL PTY LTD

ANNUAL ENVIRONMENTAL MANAGEMENT REPORT

TARRAWONGA COAL MINE (ML 1579)

01 May 2009 – 30 April 2010

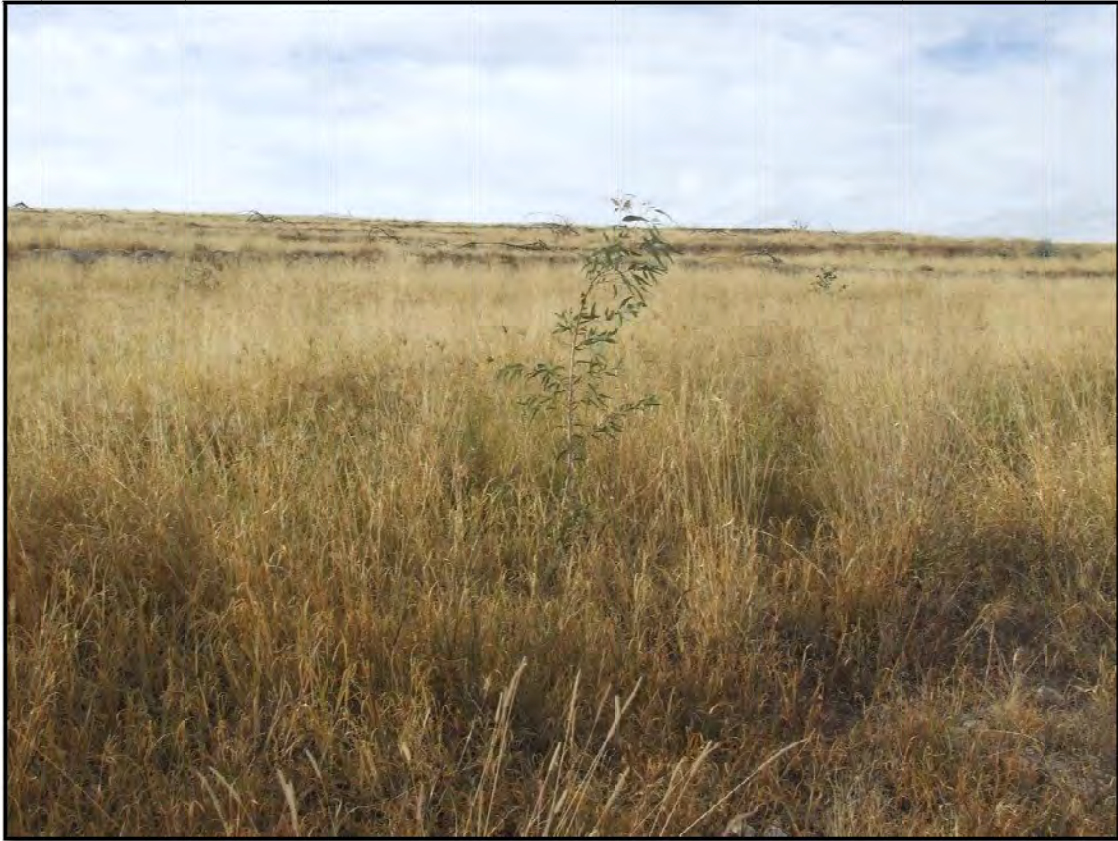
Plate 1 - Area previously identified as having poor vegetation establishment

1. The potential mining through the Tarrawonga/Idemitsu boundary has been removed from current plans. As a consequence, in pit backfilling against the highwall at the northern end of site has commenced.
2. The area determined by I&I as having poor vegetation establishment at last year's AEMR review had retained the greatest cover of vegetative matter in its second year as compared to rehabilitation of other sections of the northern emplacement over their second year. The use of a sterile Rhodes grass has given little capacity for successional invasion by roly poly or galvanised burr which has been the traditional outcome across site. This particular area has also proven to have the least amount of rilling and erosional problems as compared to other rehabilitated areas due to the extent of cover that has been maintained (Plate 1).

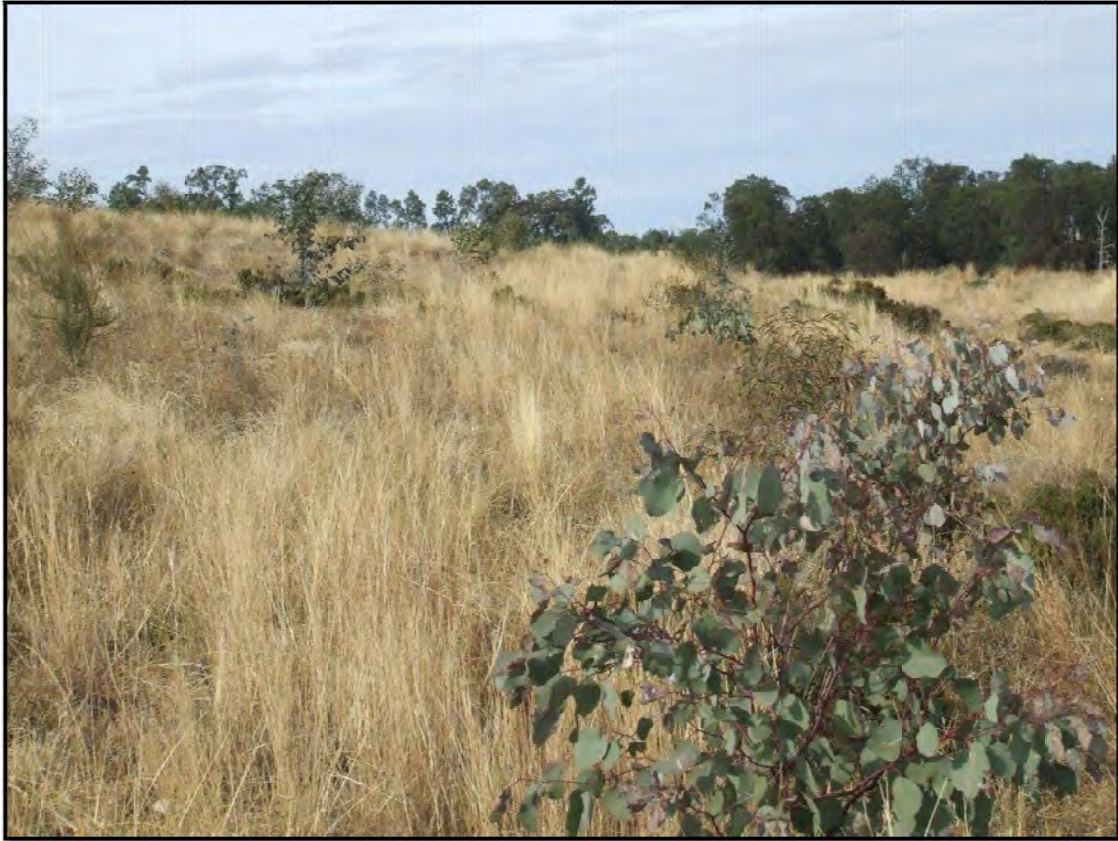
Plate 2 - 2007 rehabilitation succession from roly poly dominance to native grasses establishment

3. Areas of original rehabilitation are showing successional development with the extent of roly poly in those areas diminishing, with a greater coverage of native grasses now coming through (Plate 2). This was identified at the last AEMR review as a normal successional development as has been proven at Whitehaven's Canyon Mine site over a number of years.

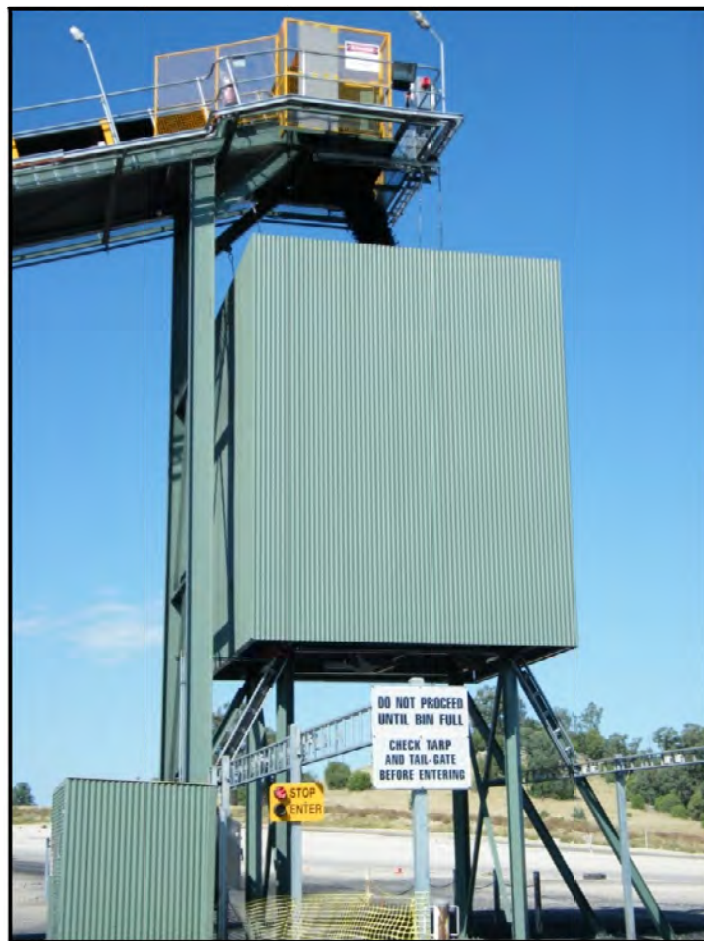
Plate 3 - Tarrawonga Coal Loader

During the reporting period, all Tarrawonga coal was transported to the Whitehaven Siding CHPP (Figure 1) where 78% was washed and 22% bypass coal (unwashed) for despatch to domestic and export markets. The Tarrawonga Coal Loader is shown in Plate 3 and Plate 4.

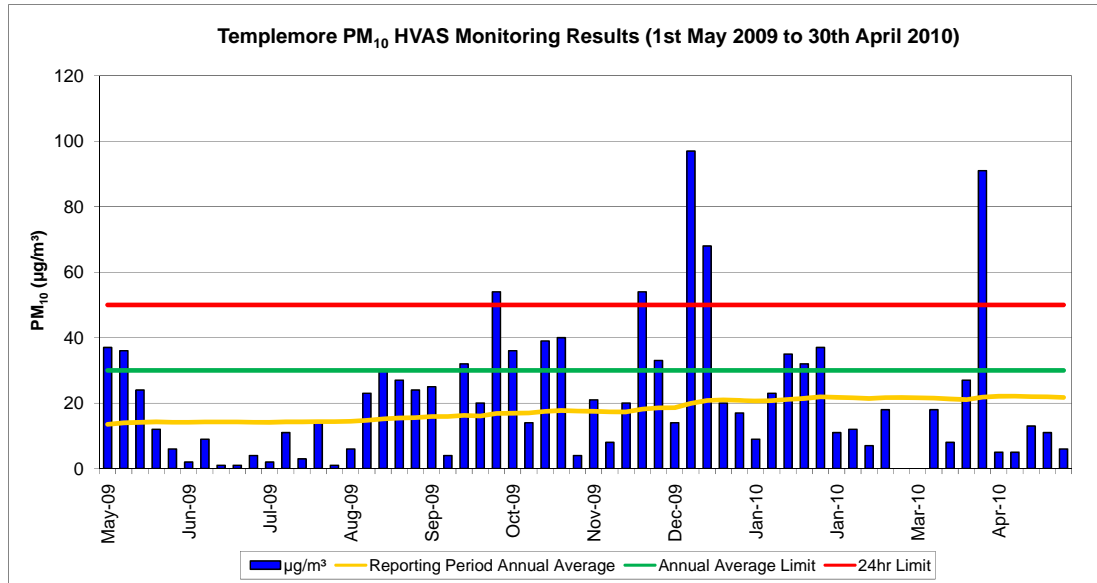
**Figure 4 - Templemore HVAS PM10 Data
May 2009 – April 2010**

The “Templemore” monitor remains within the annual average compliance criteria of 30 µg/m³, with the running annual average currently on 21.74 µg/m³.

The exceedances in the 24hr criteria were reviewed in terms of available weather conditions and regional conditions on the day. The event of the 27th September 2009 was influenced by regional dust storms in the locality. The event of the 20th November 2009 was not characterised by any significant event in the locality, albeit westerly and south-westerly winds were predominant at the time of the sampling event which is indicative of other factors influencing PM10 levels. The exceedances on the 8th and 14th December 2009 related to bushfires in the locality, with significant smoke haze present on a regional basis. It is also noteworthy that the PM₁₀ unit in Tamworth operated by the DECCW experienced an increase in PM₁₀ over the period 8th – 14th December with PM₁₀ levels ranging from 24 µg/m³ to 325 µg/m³, which indicates general regional conditions were responsible for the higher concentrations recorded at the Templemore monitor. The exceedance of the 26th March 2010 occurred with winds predominantly from the north east and south west, indicative of other non mine-related influences on PM₁₀ levels.

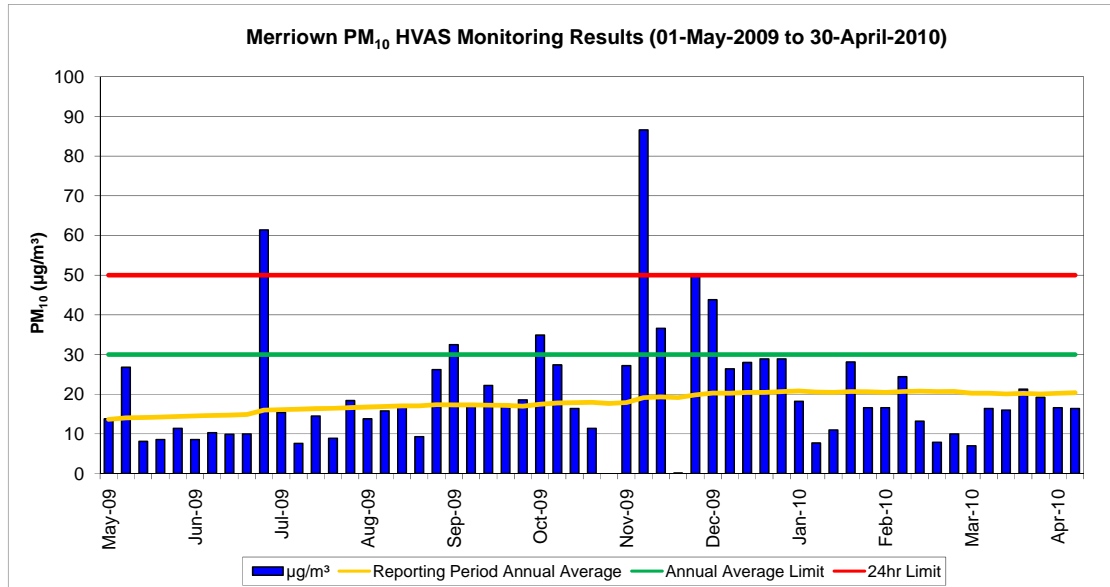
**Figure 5 - Merriown HVAS PM10 Data
May 2009 – April 2010**

The “Merriown” monitor remains within the annual average compliance criteria of 30 µg/m³, with the running annual average currently on 20.26 µg/m³. This result is consistent with the “Templemore” result.

The exceedances in 24hr criteria were assessed against the available weather conditions on the day and overall regional conditions. The exceedance of the 30th June was characterised by wind direction predominantly from the west which would indicate other factors impacting on PM₁₀ levels. The event of the 19th November was also characterised by westerly or south easterly winds which is also indicative of other factors impacting on PM₁₀ levels on that day.

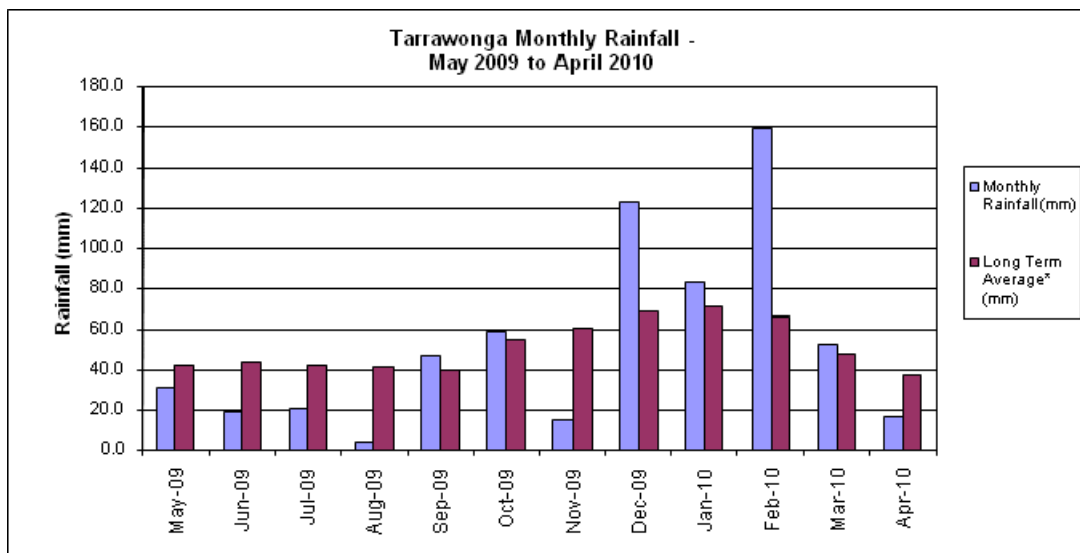
Figure 6 – Monthly Rainfall Data

A review of Table 13 and Figure 6 shows that the total rainfall at the mine during the reporting period was 630.8mm. The total rainfall at the site was 12.9mm higher than the annual average rainfall for Gunnedah and 48mm lower than the mine's total rainfall for the 2008/2009 AEMR reporting period. Below average rainfall was

The majority of rainfall occurred during the months of December 2009, January 2010 and February 2010. Conditions during the latter part of 2009 were particularly hot and dry, as evidenced by the dusty conditions experienced throughout September and October. Site water storages were almost dry in December 2009 prior to over 170mm of rainfall during the period 22nd December 2009 – 3rd January 2010. This significant amount of rainfall resulted in discharges as discussed in Section 3.3.2.

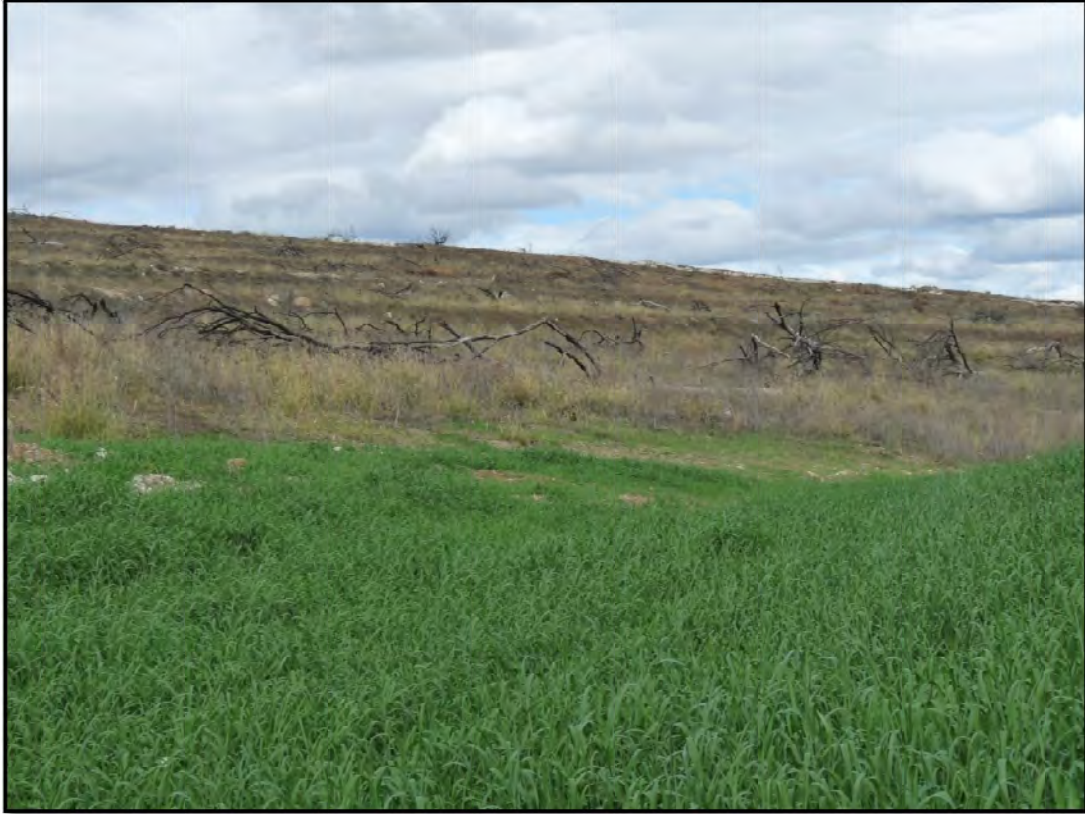
Plate 5 - 12 month old rehabilitation in background, with new cover crop establishment on new rehabilitation in foreground

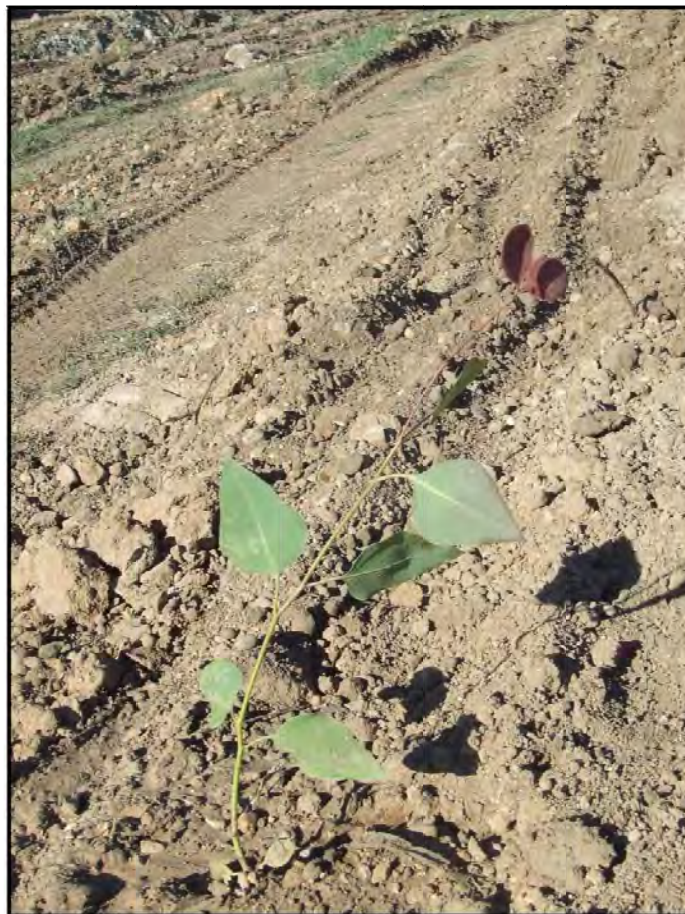
Plate 7 – Tubestock planting in mounds

Drip irrigation was not undertaken in planted areas over the reporting period. As a trial, Tarrawonga Coal arranged for mounding instead of ripping in preparation for tubestock planting at the northern and southern ends of the western emplacement. The use of mounds has appeared to provide improved moisture retention and to benefit the planted tubestock. It also provides the additional advantage of reducing slope length between contours for surface flows to cause active rilling on rehabilitated slopes. Given the success from this treatment, mounding will be the preferred preparation for tubestock planting into the future, particularly on the slopes.
