Narrabri Coal Mine Community Consultative Committee Meeting #10

Environmental Monitoring Report May 2010 – July 2010

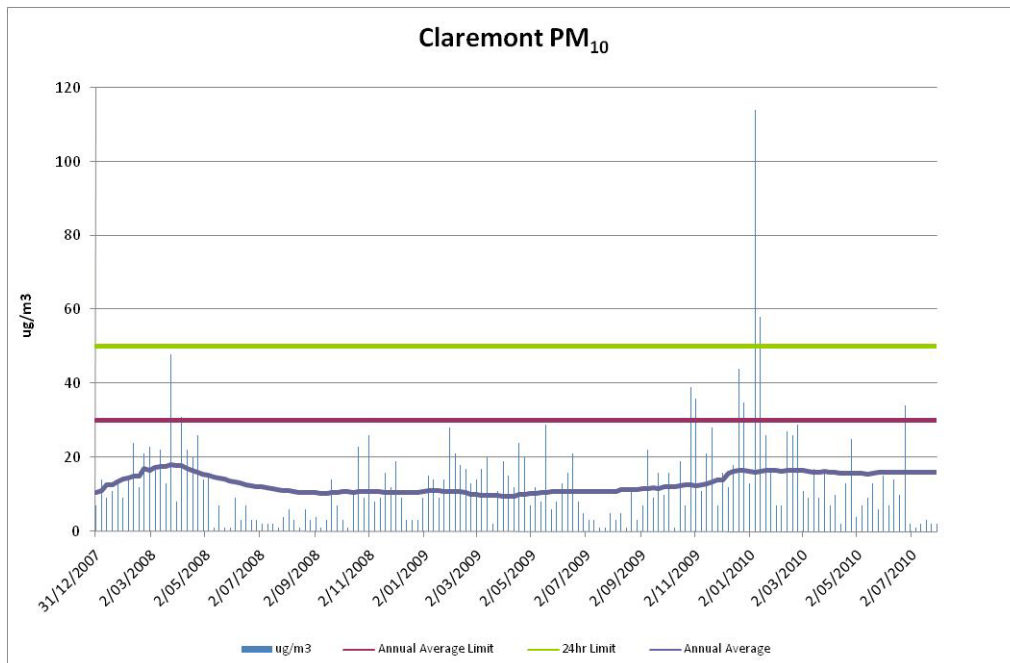
PM₁₀ measurements taken to date for the “Claremont” High Volume Air Sampler is returning a running annual average of $16.0 \text{ } \mu\text{g/m}^3$ which is well below the annual average limit of $30 \text{ } \mu\text{g/m}^3$.

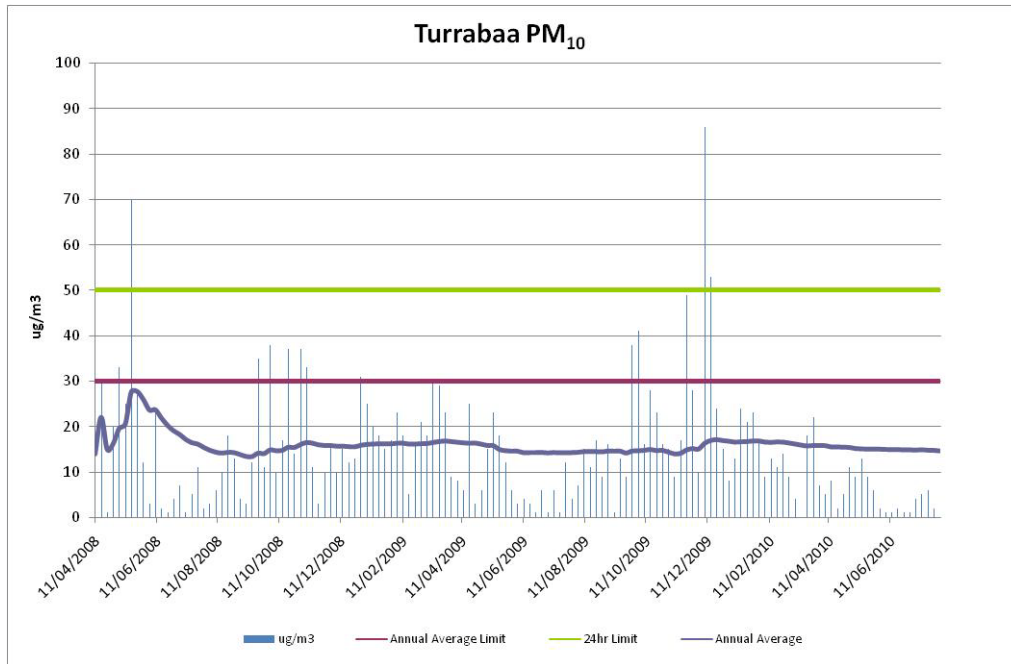
PM₁₀ measurements taken to date for the “Turrabaa” High Volume Air Sampler is returning a running annual average of $14.66 \text{ } \mu\text{g/m}^3$ which is also well below the annual average limit of $30 \text{ } \mu\text{g/m}^3$.

PM₁₀ levels have remained compliant over the past month.

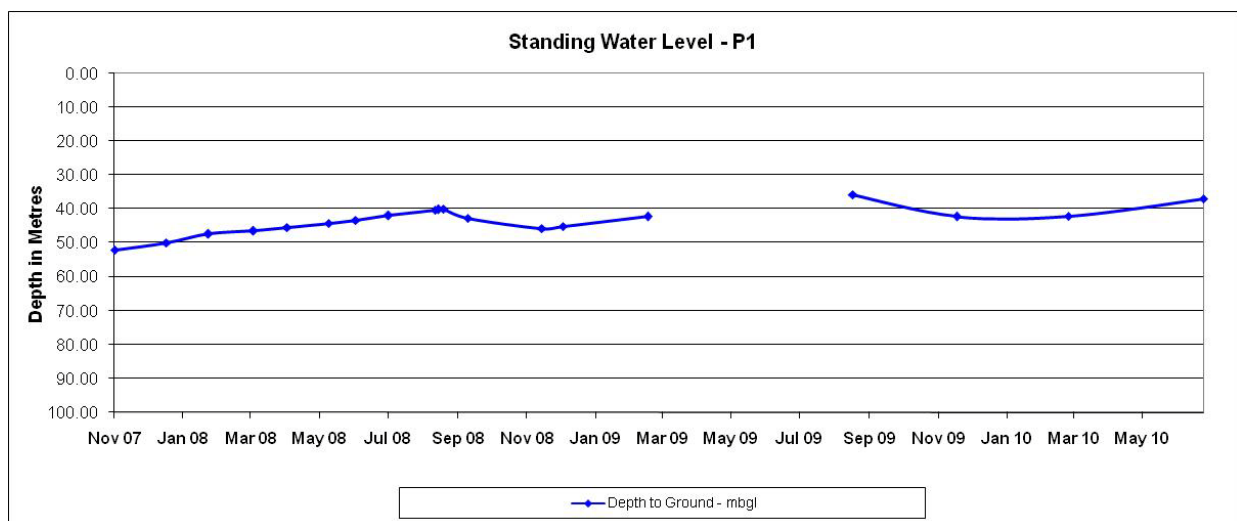
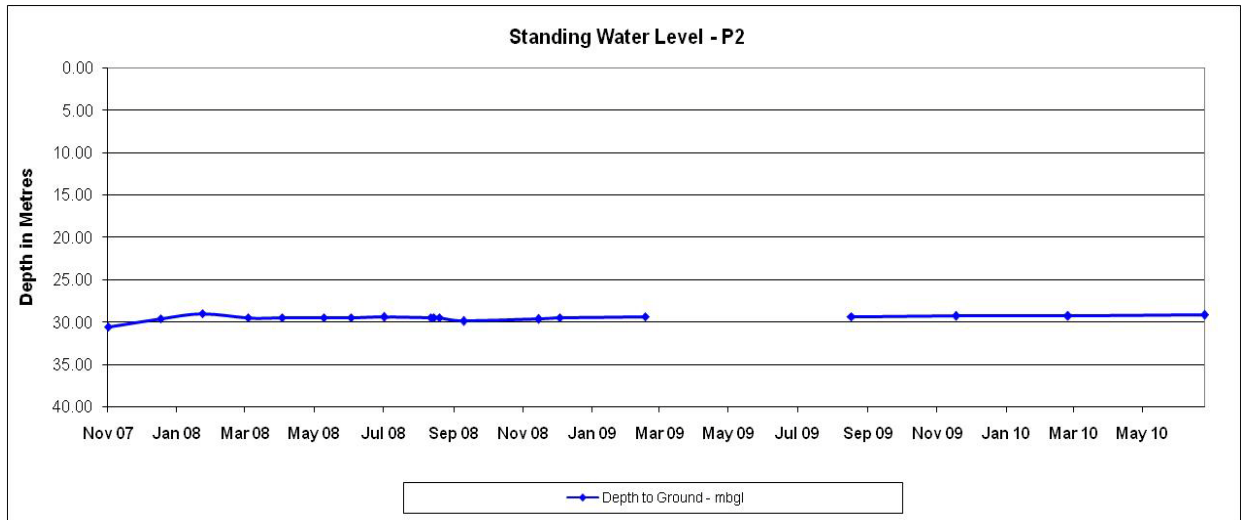
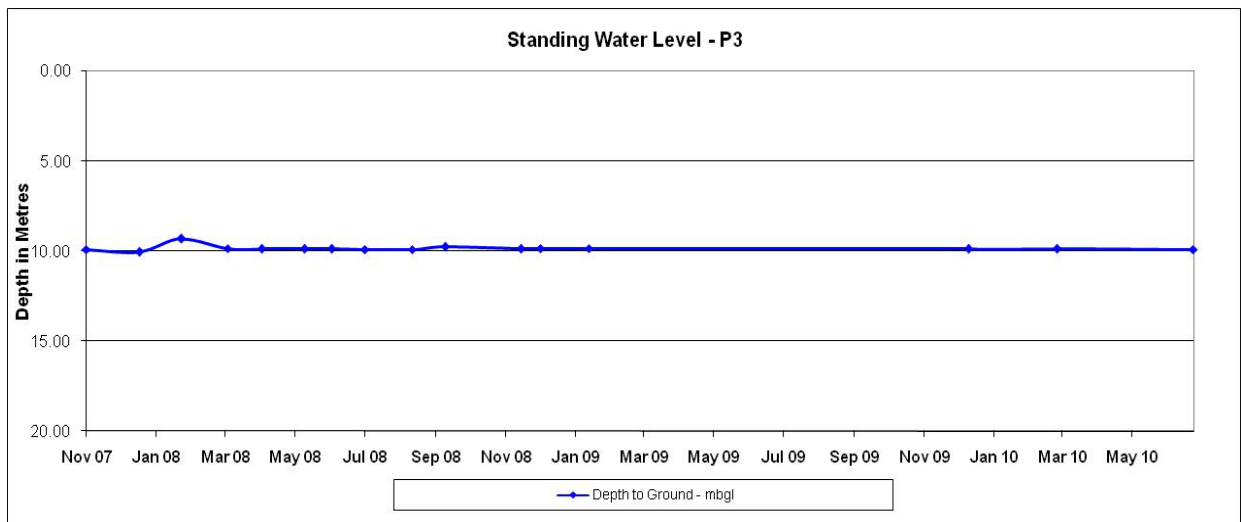
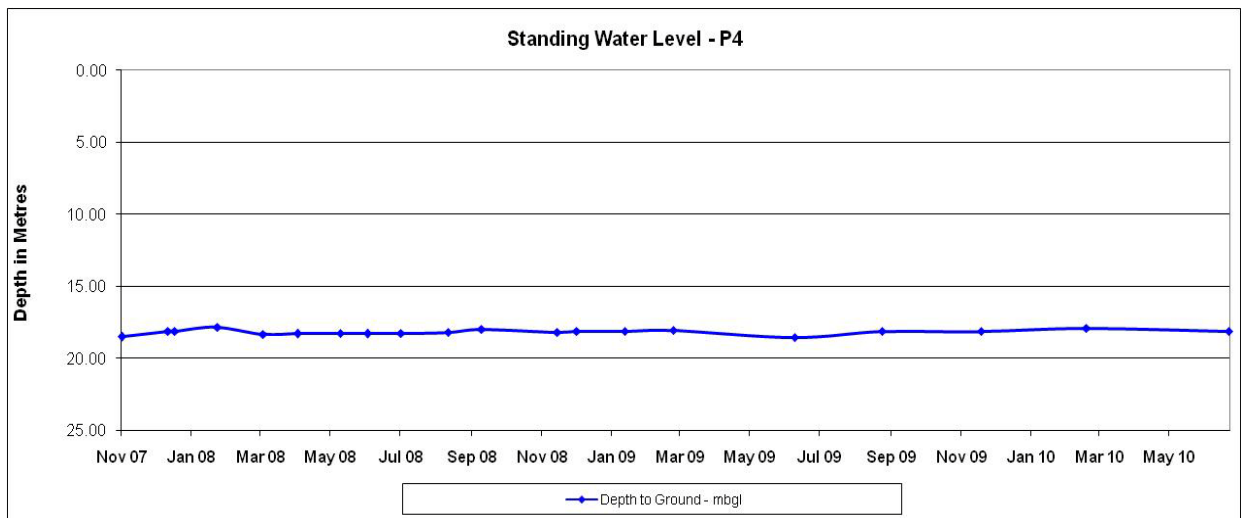
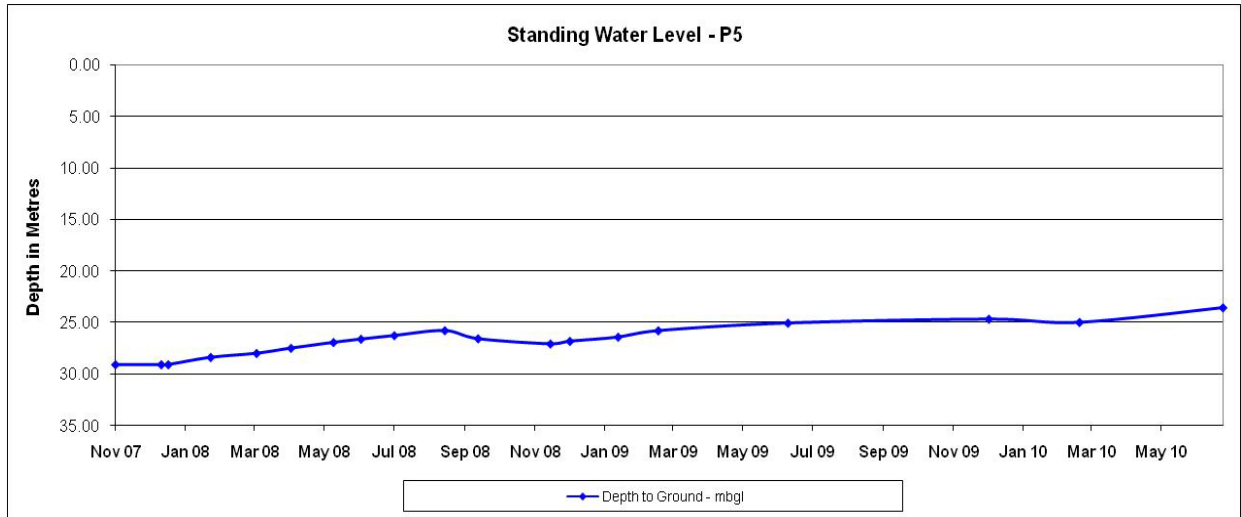
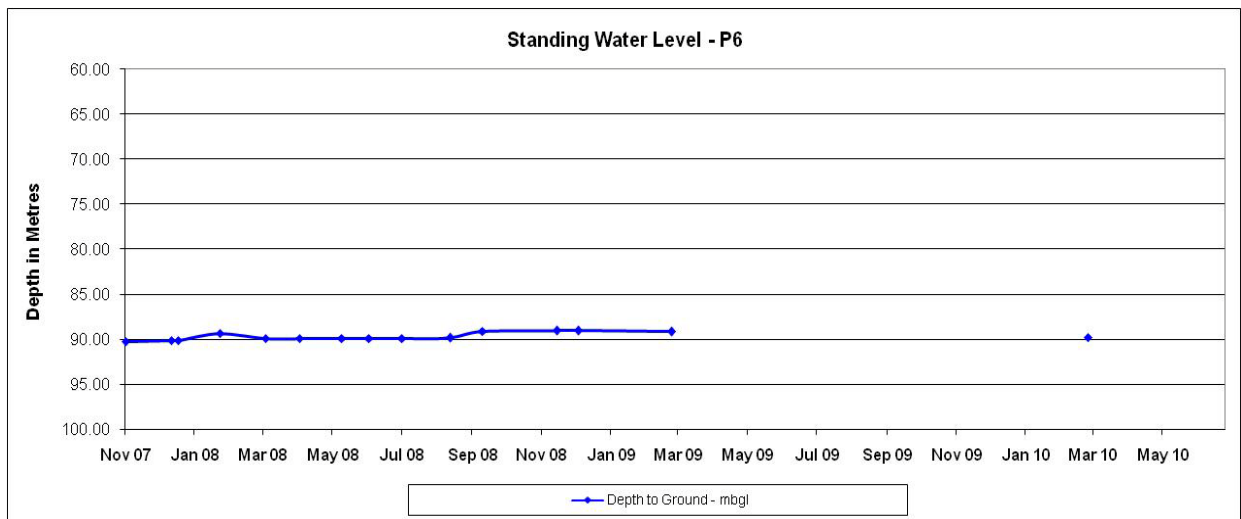
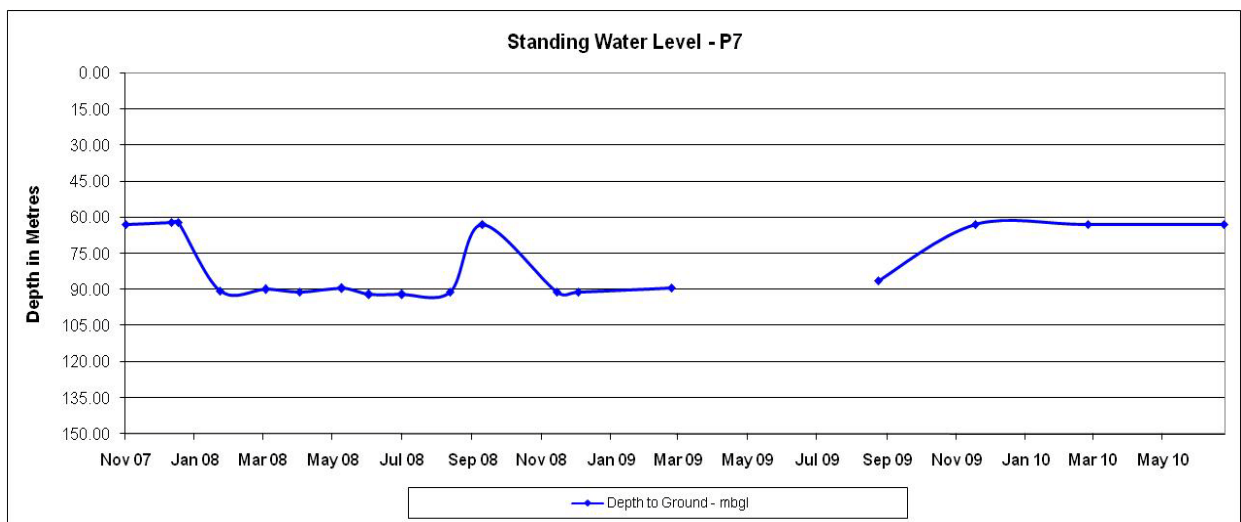
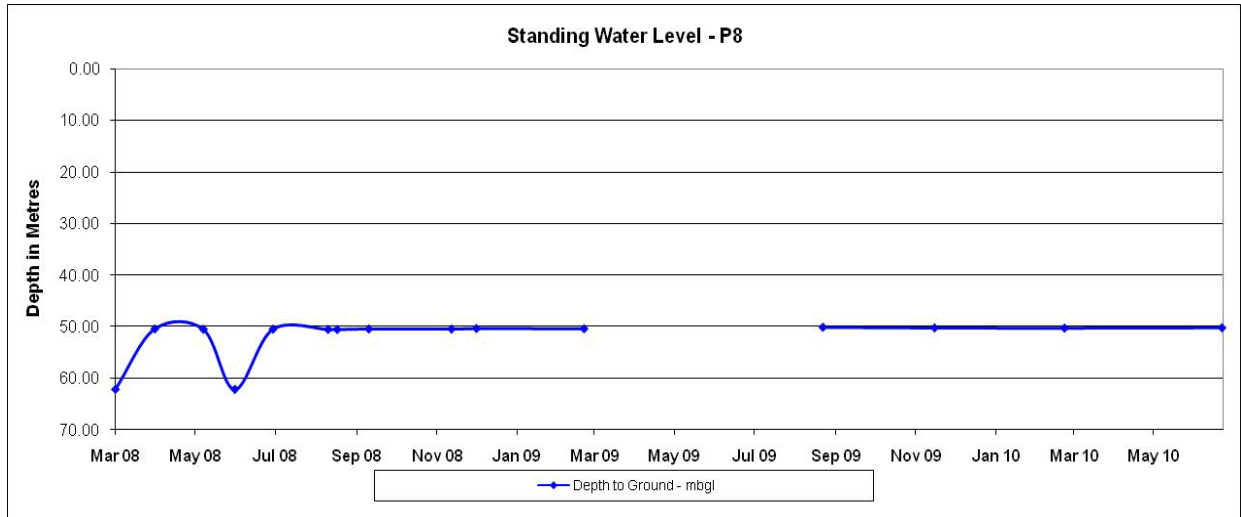
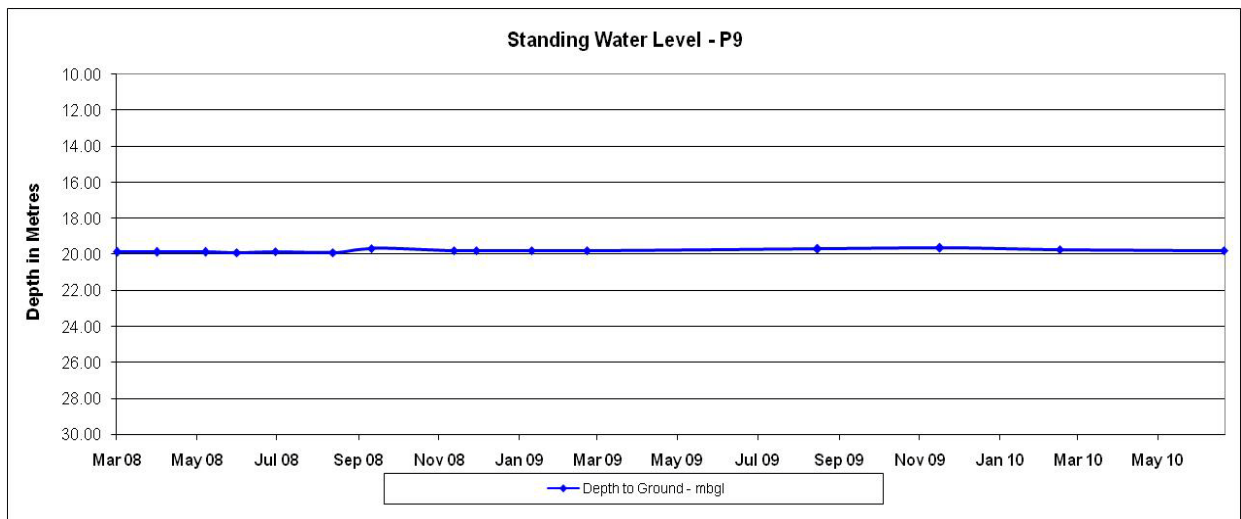
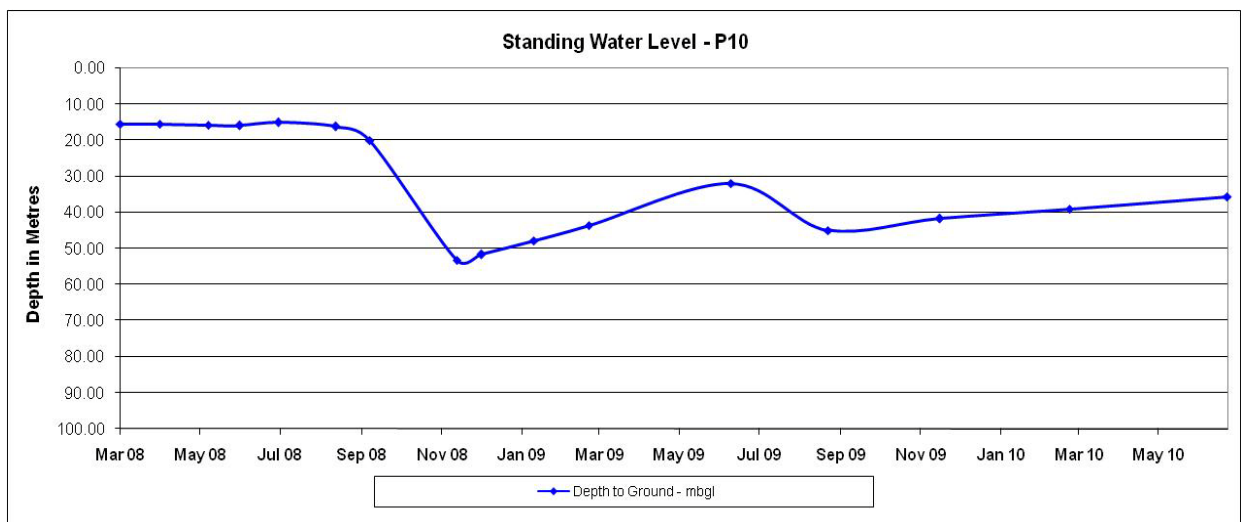
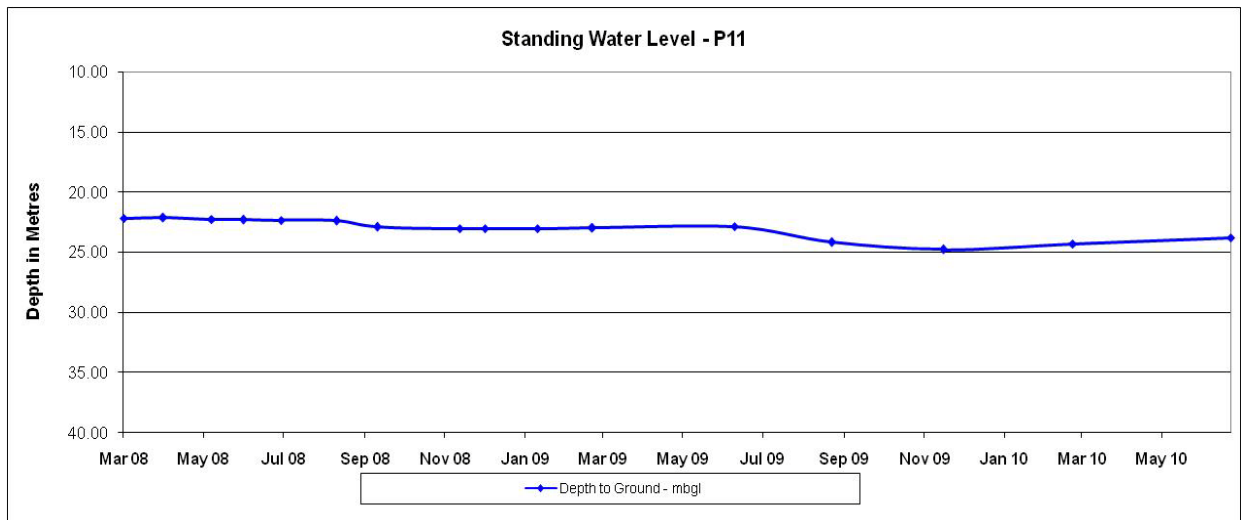
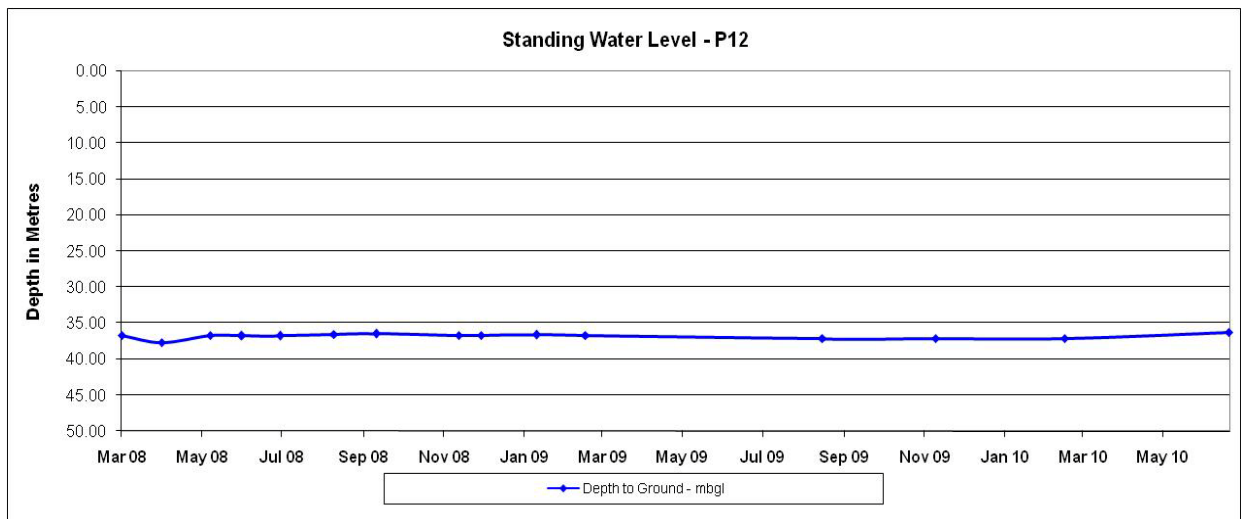
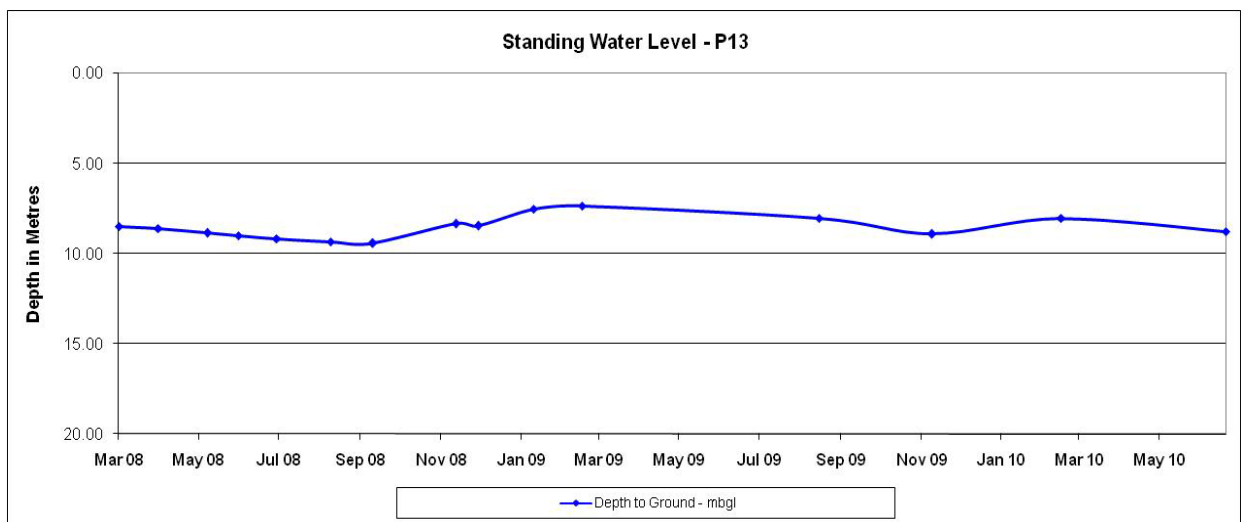
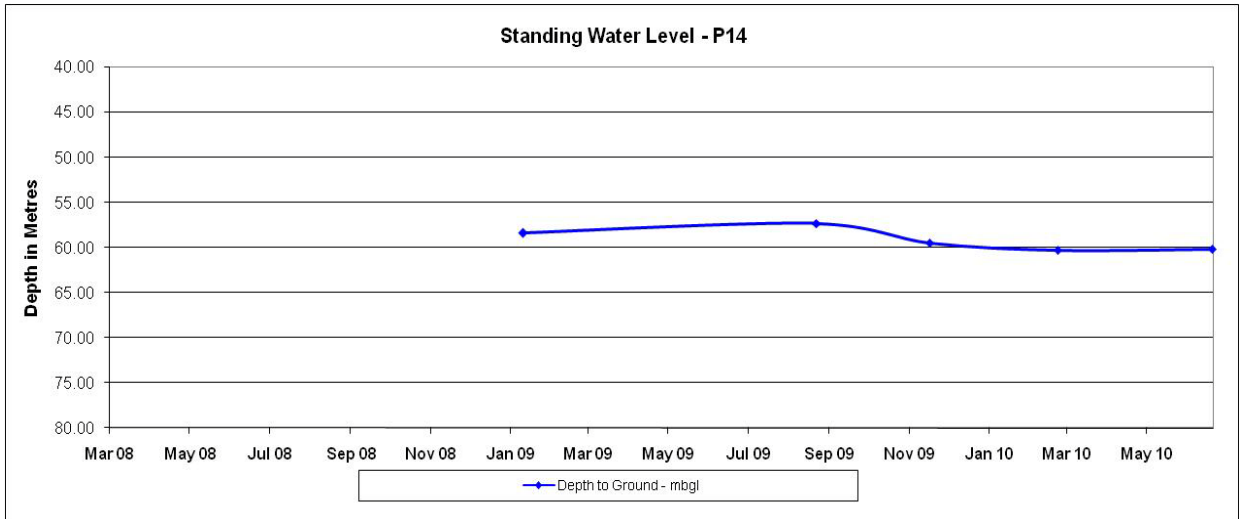
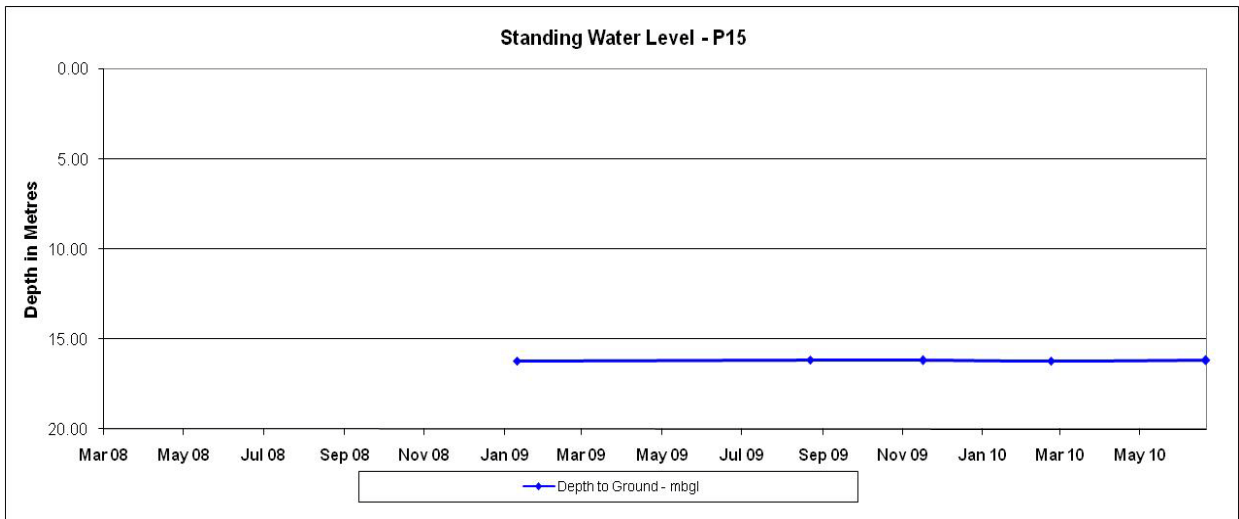
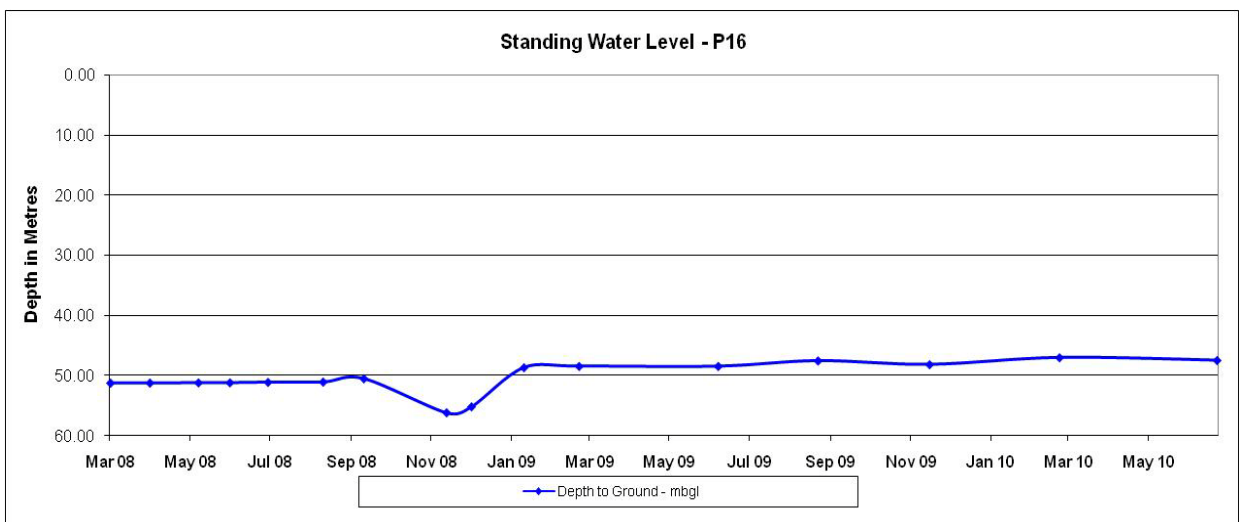
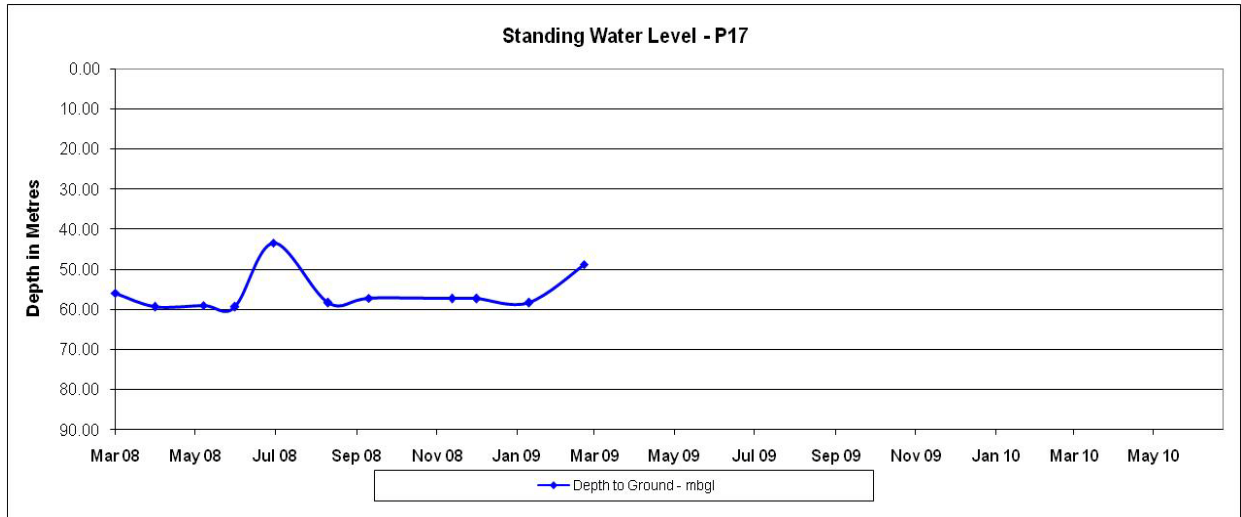
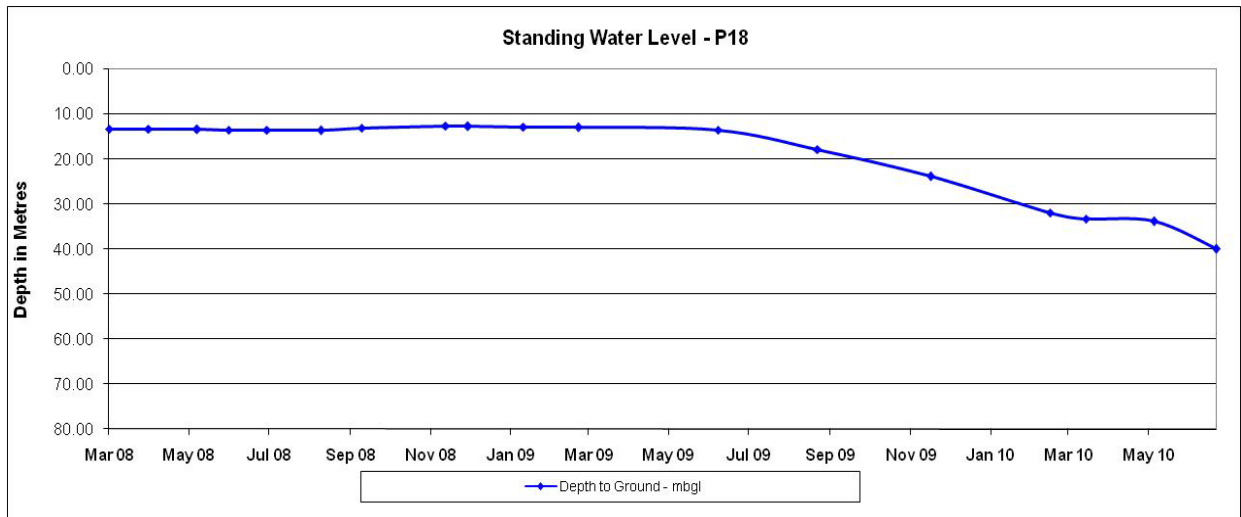
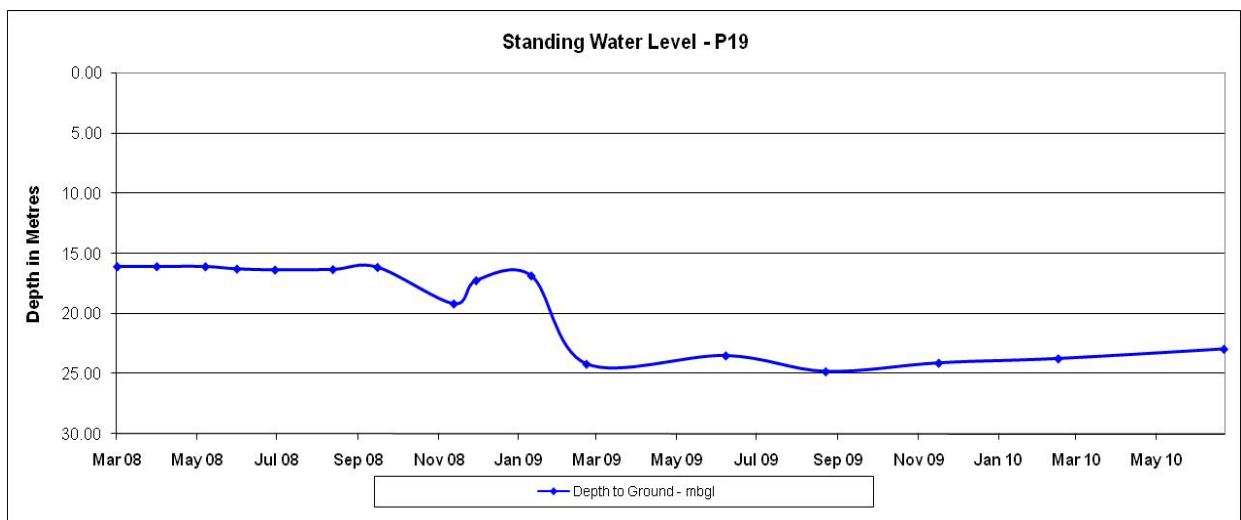
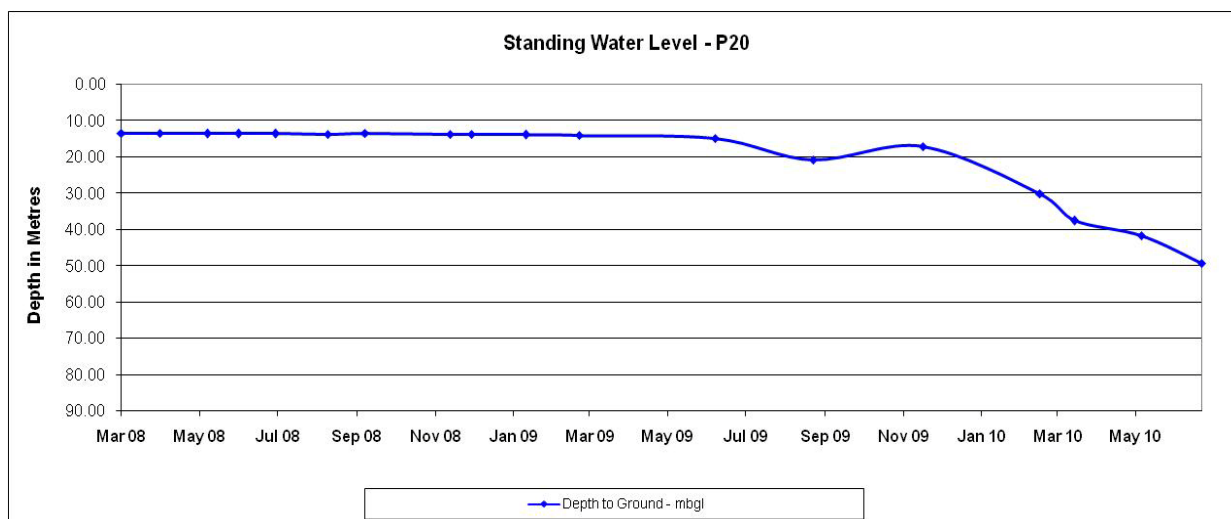
The graphs below show the SWL trends at each site since monitoring commenced. In general, groundwater levels have remained relatively constant over the last 6 months with the exception of P18 and P20. These piezometers are located approximately 1.5km north-east of the surface facilities and the drop in SWL is likely associated with water extraction from the coal seam. P20 has recently been grouted and will therefore no longer be monitored. This was required as the piezometer was due to be intersected by a lateral gas drainage hole.
