Sunnyside Coal Mine Community Consultative Committee Meeting #10

Environmental Monitoring Report March 2011 – May 2011

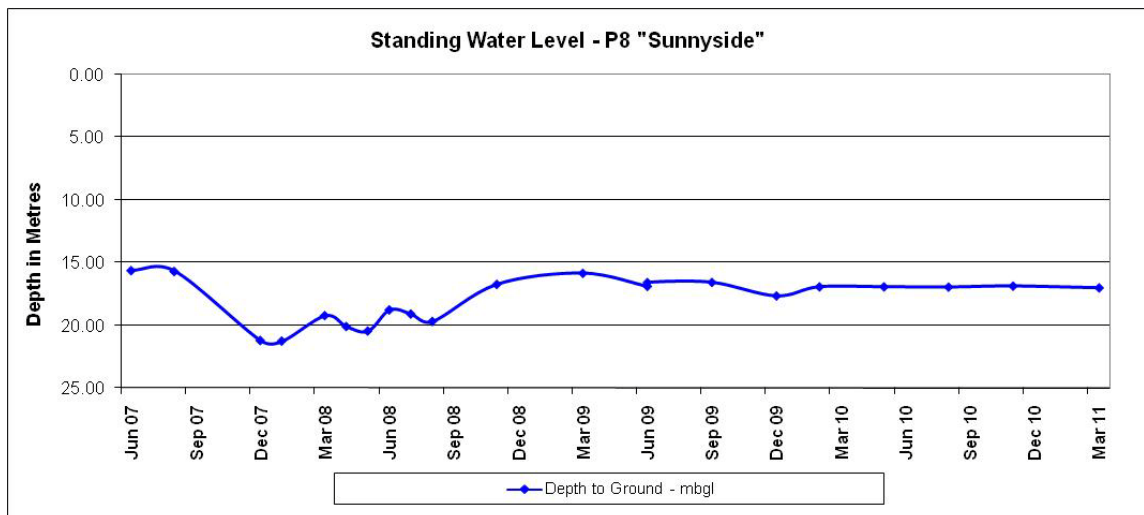
Groundwater monitoring is undertaken from a range of monitoring piezometers and water bores both within and surrounding the mine site. Standing Water Level (SWL) checks are undertaken on a quarterly basis, with full water quality sampling undertaken on a 6 monthly basis. Monitoring was undertaken on the 8th and 9th March 2011 with results for SWL shown below, with no significant impact/trend indicated from mining operations. The next round of monitoring is expected to be conducted during June 2011.

The above results indicate minor variability in groundwater levels with no significant trend applicable. These graphs represent water bores and piezometers which are currently accessible for monitoring.
