ROCGLLEN COAL MINE - MINING OPERATION PLAN

Cross Sections

Date: 12-08-11	Scale: Refer scale bar	Plan No.: 7
Prepared by: GSS Environmental

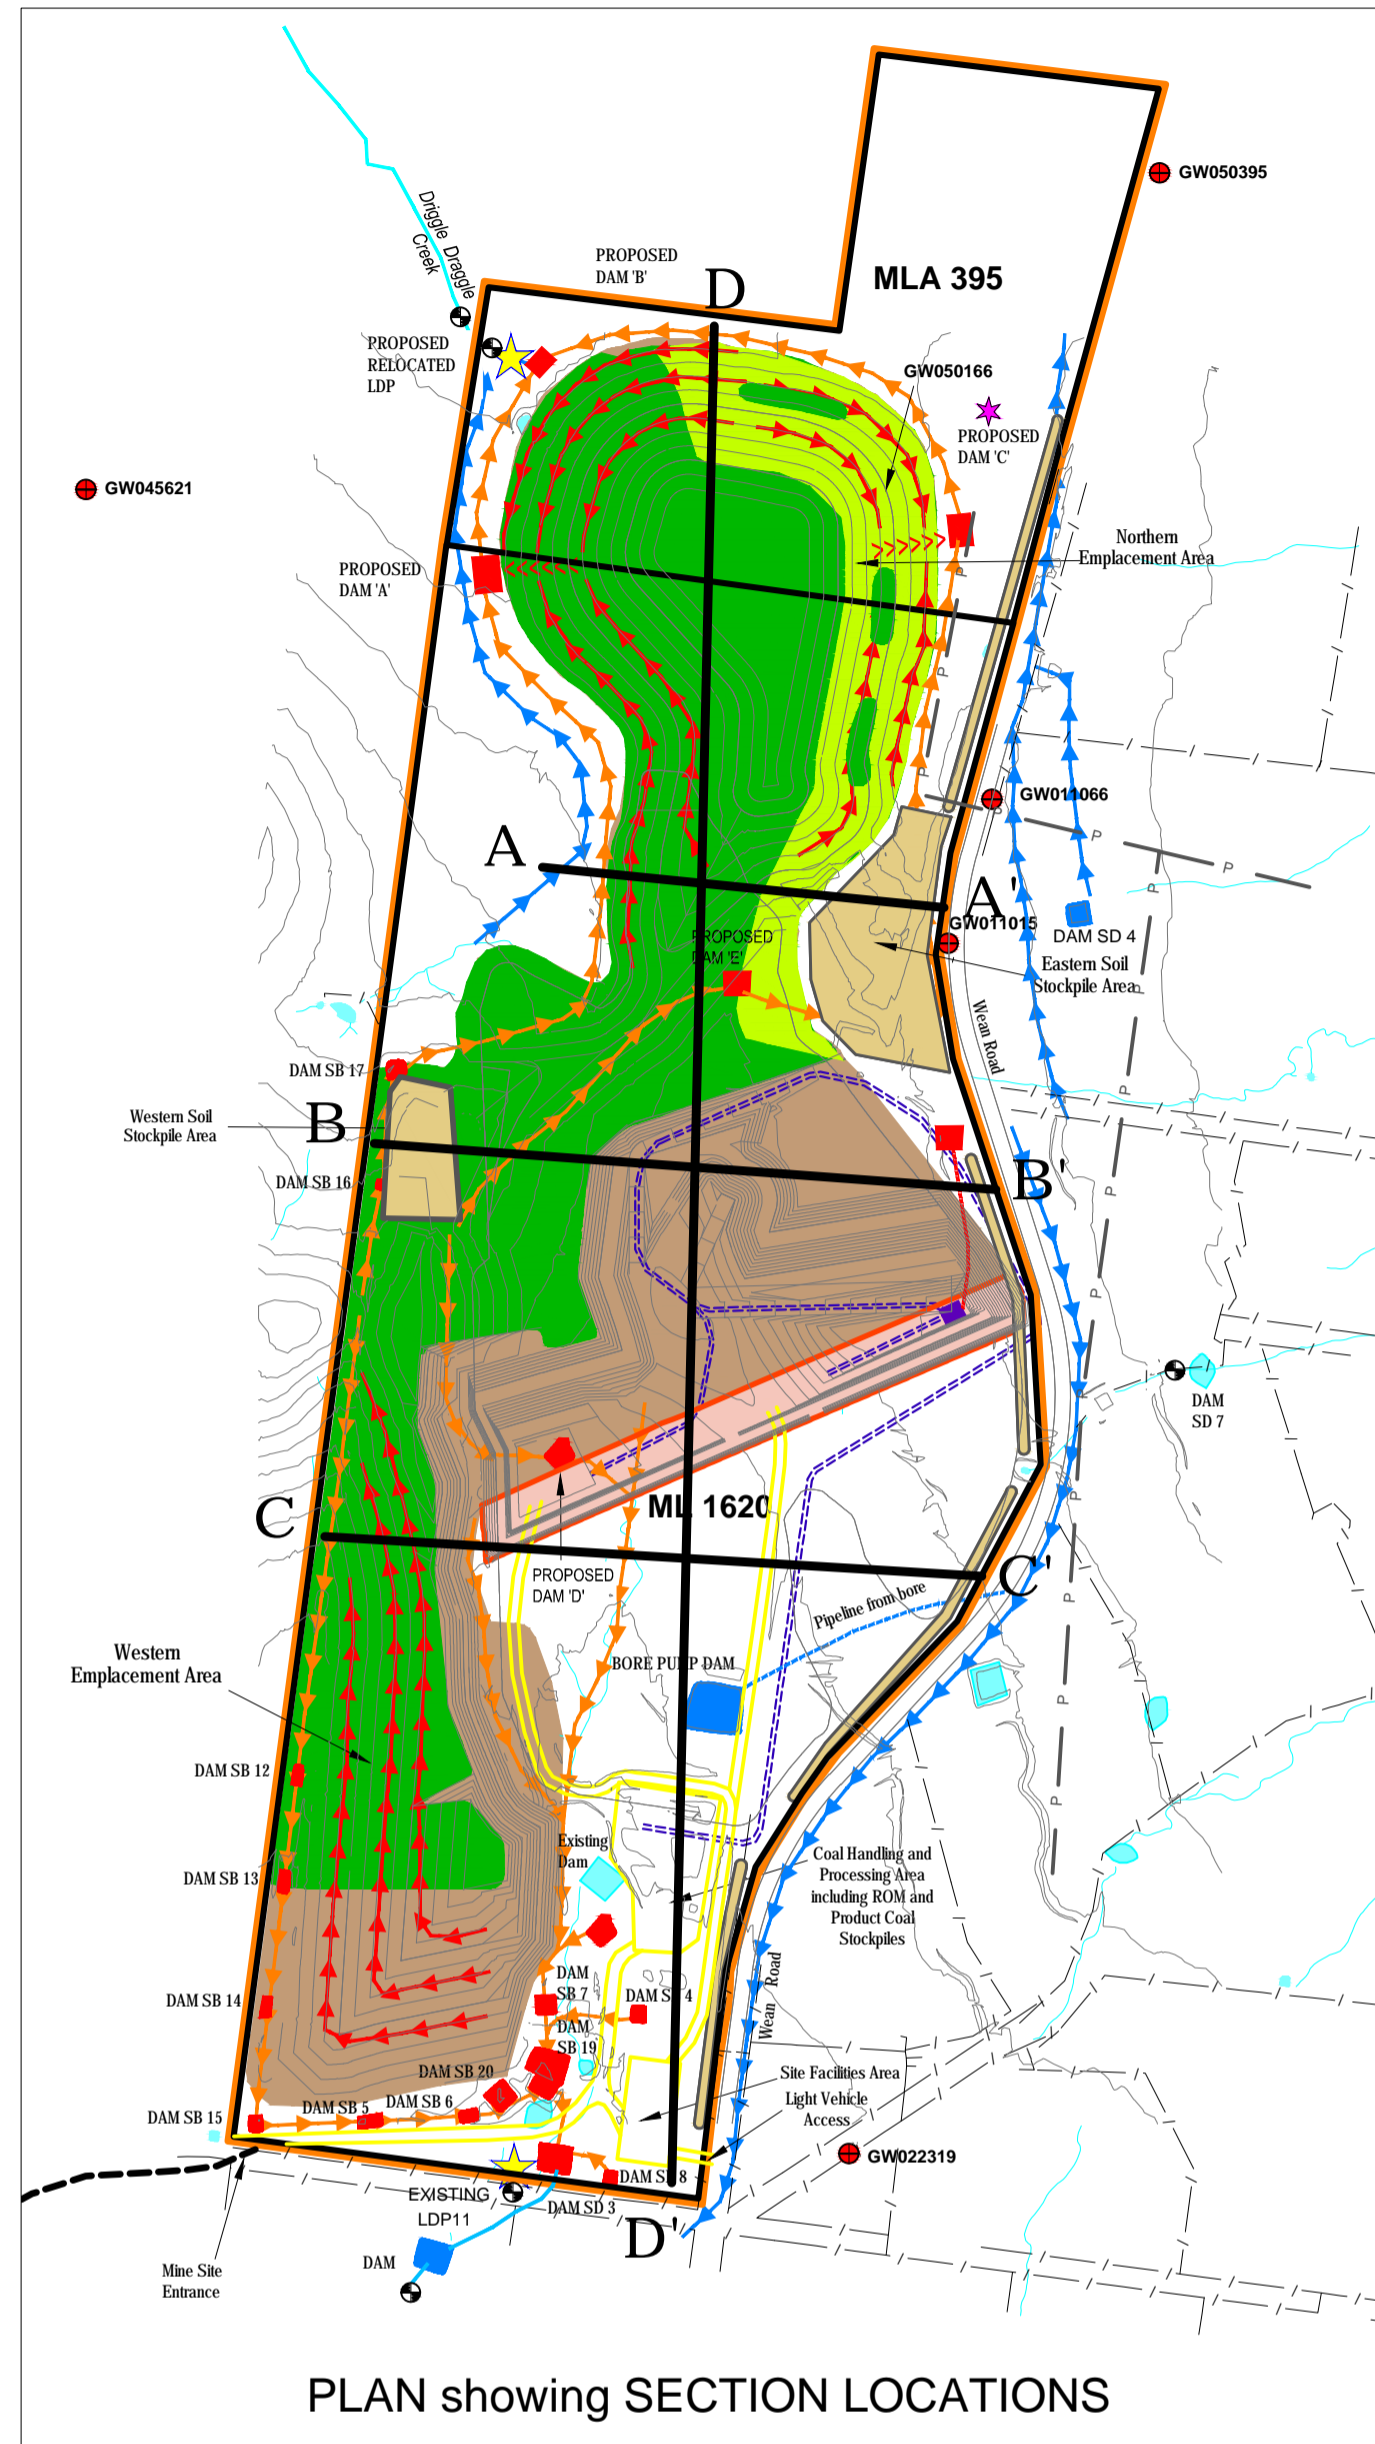
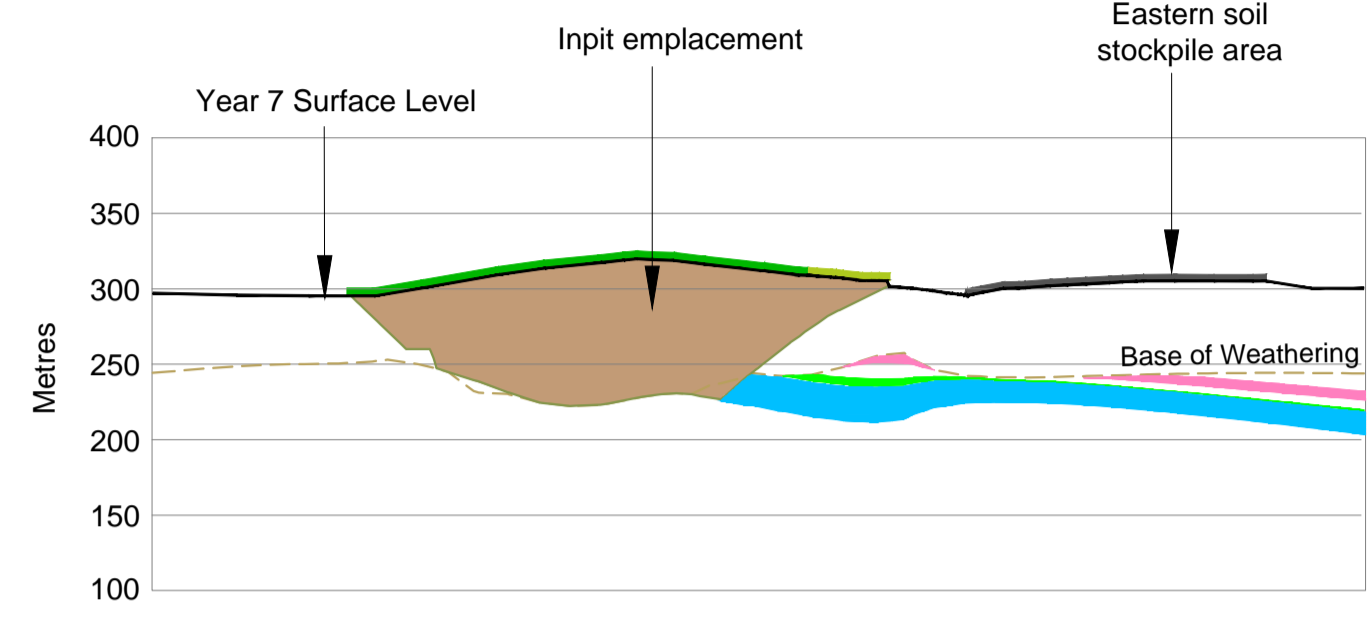
NOTE:
Where resources allow, topsoil and subsoil will each be spread on shaped landform ready for rehabilitation to a nominal depth of between 100 to 150 millimetres, giving a combined depth of soil material on the rehabilitated landform of between 200 and 300 millimetres.
